Glennstone Phase 3 Dry Pond 3

(City of Durham ID# 00410)

Annual Certification Inspection Journal (ACIJ) – Interim Report

July 2020

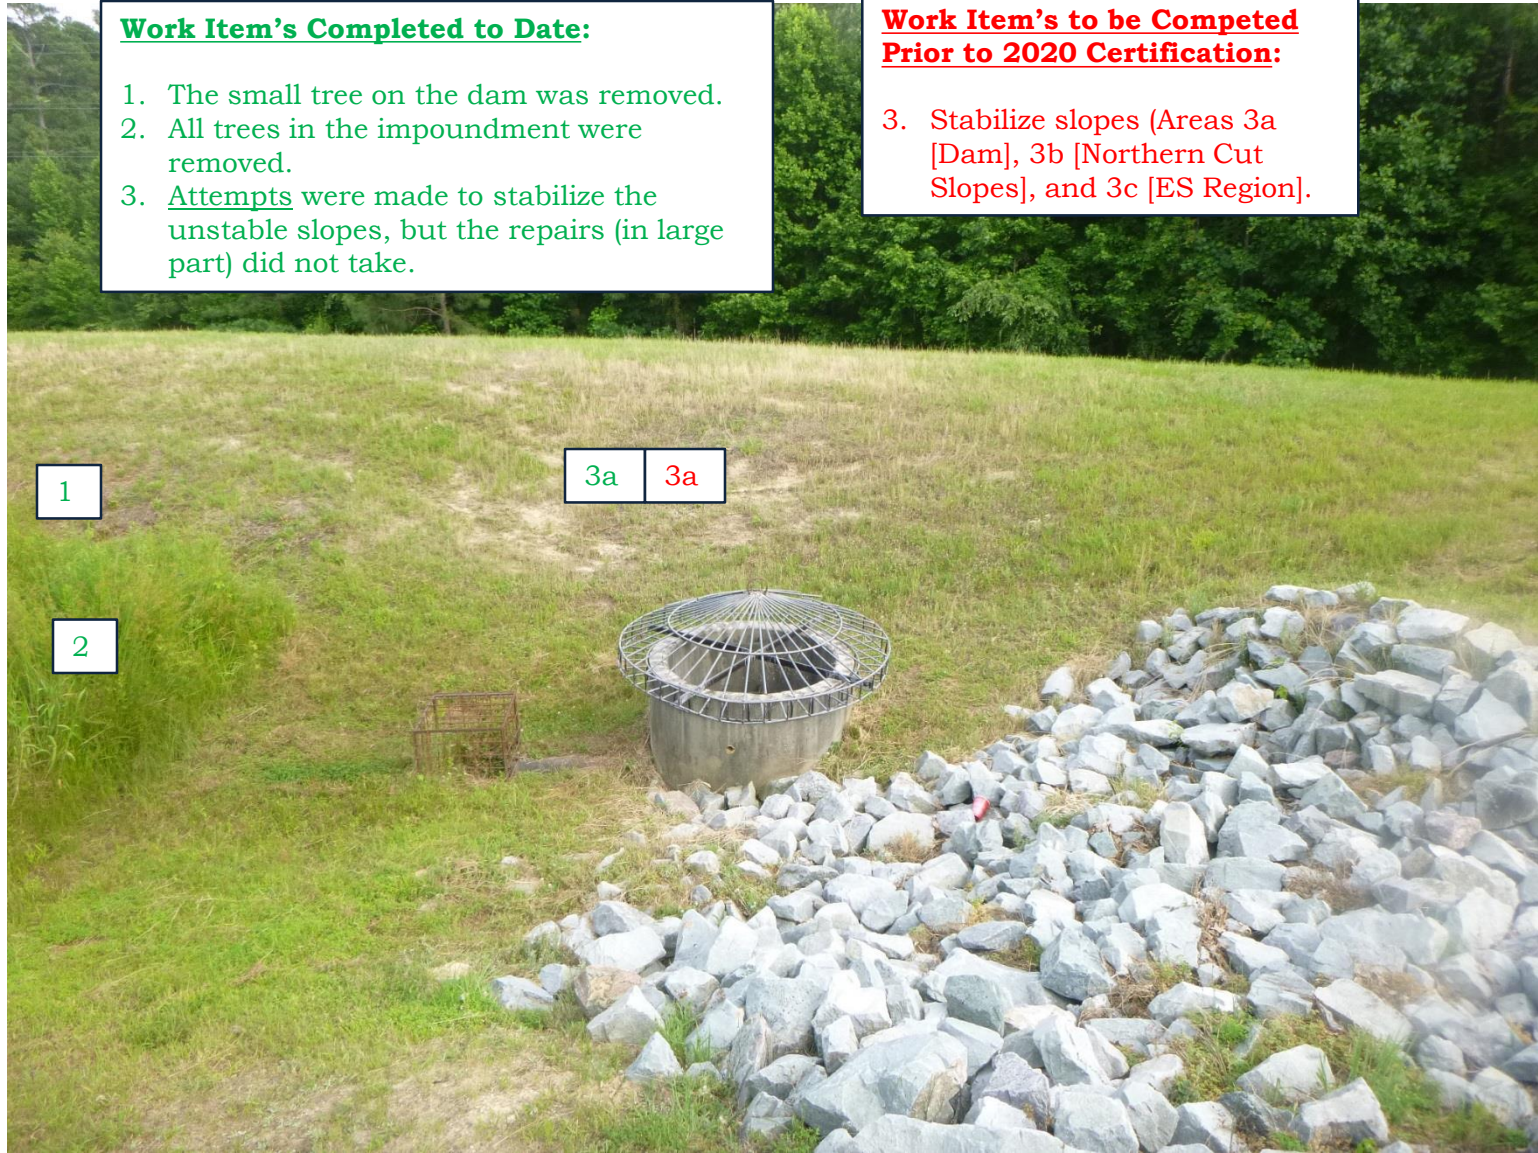
1. The small tree on the dam was removed.
2. All trees in the impoundment were removed.
3. Attempts were made to stabilize the unstable slopes, but the repairs (in large part) did not take.

3. Stabilize slopes (Areas 3a [Dam], 3b [Northern Cut Slopes], and 3c [ES Region]).

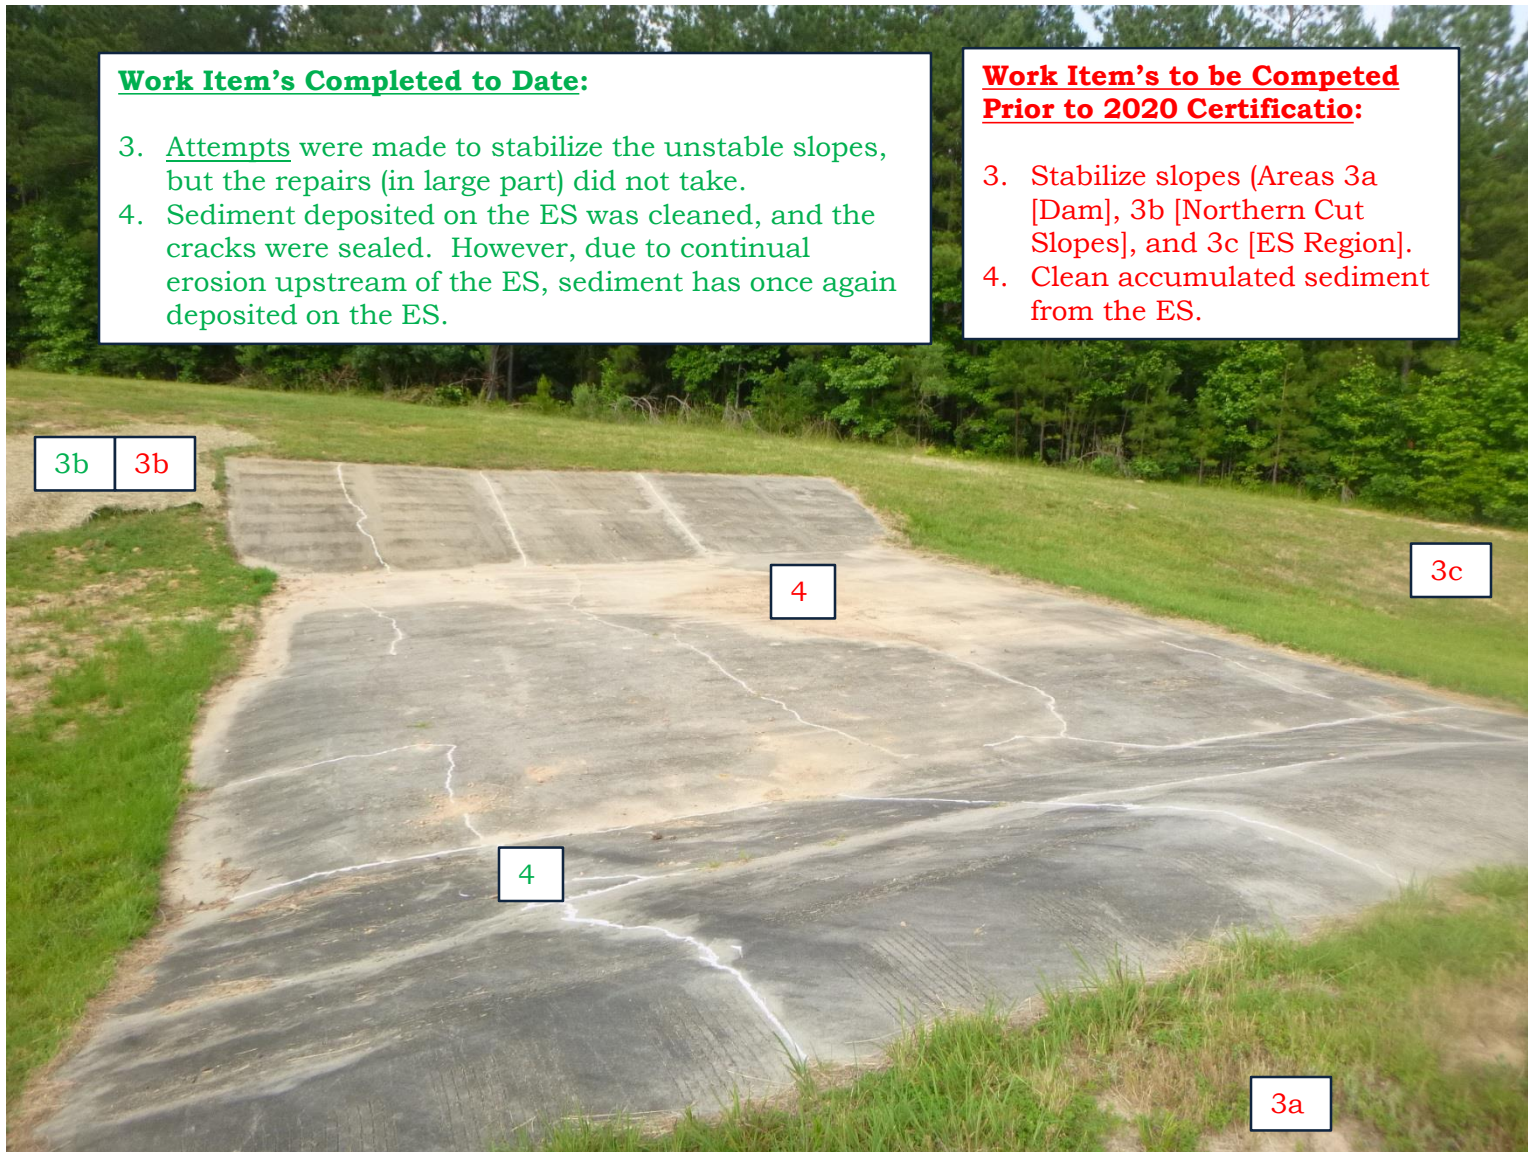
- 3. Attempts were made to stabilize the unstable slopes, but the repairs (in large part) did not take.
- 4. Sediment deposited on the ES was cleaned, and the cracks were sealed. However, due to continual erosion upstream of the ES, sediment has once again deposited on the ES.

- 3. Stabilize slopes (Areas 3a [Dam], 3b [Northern Cut Slopes], and 3c [ES Region]).
- 4. Clean accumulated sediment from the ES.

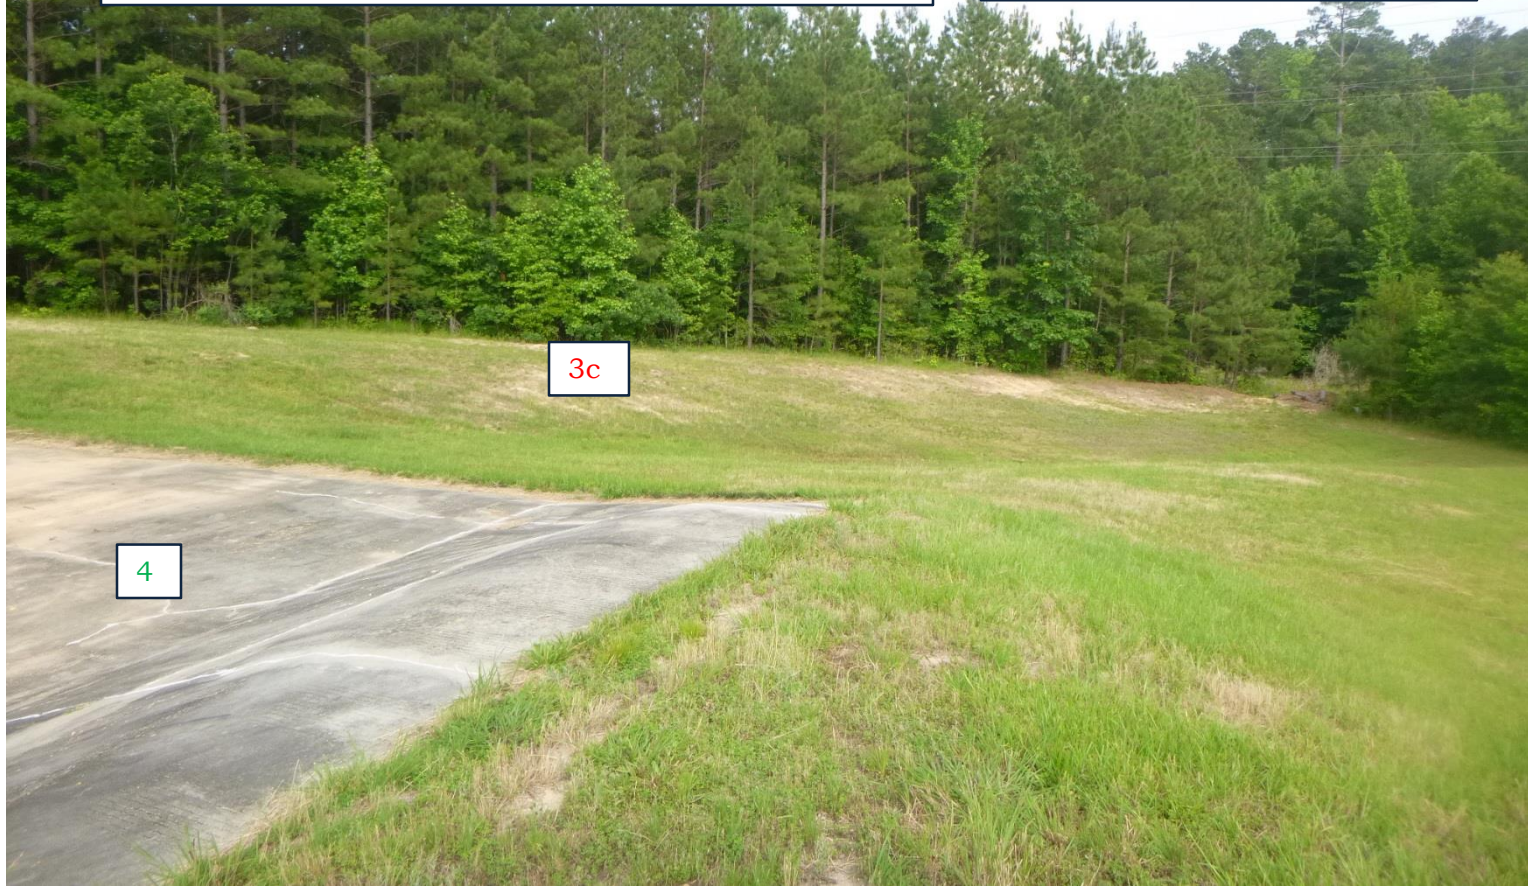
4. Sediment deposited on the ES was cleaned, and the cracks were sealed. However, due to continual erosion upstream of the ES, sediment has once again deposited on the ES.

3. Stabilize slopes (Areas 3a [Dam], 3b [Northern Cut Slopes], and 3c [ES Region]).

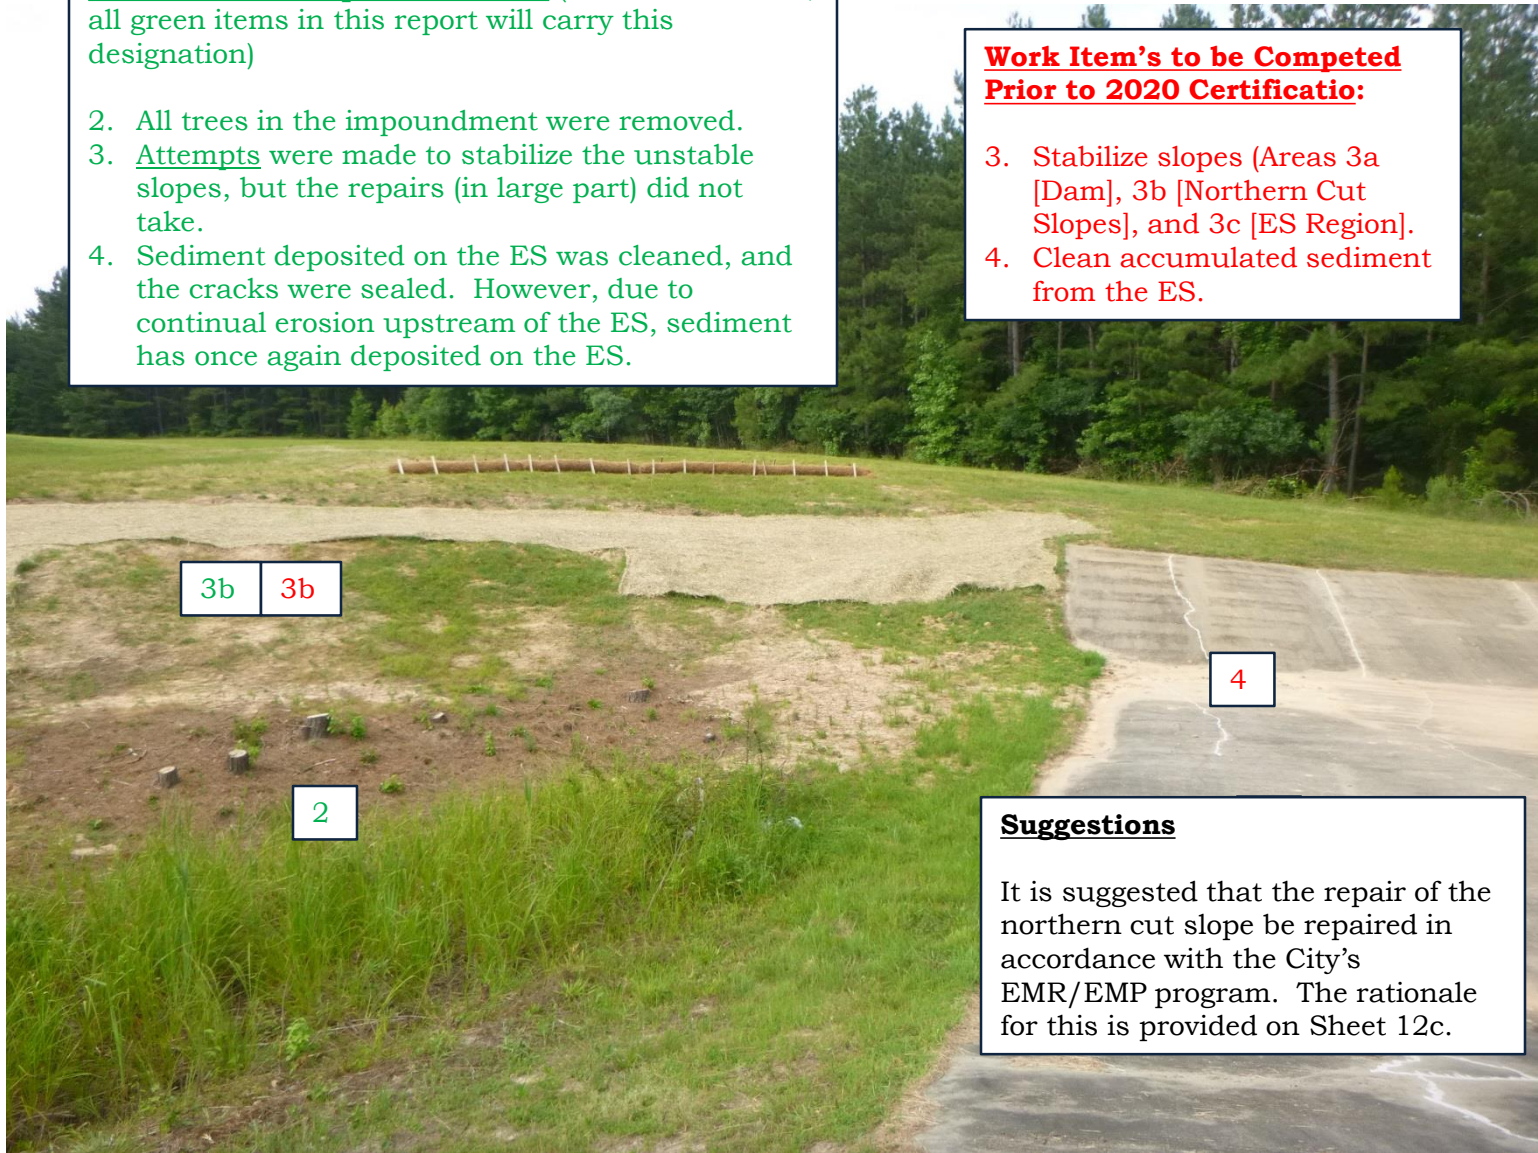
2. All trees in the impoundment were removed.
3. Attempts were made to stabilize the unstable slopes, but the repairs (in large part) did not take.
4. Sediment deposited on the ES was cleaned, and the cracks were sealed. However, due to continual erosion upstream of the ES, sediment has once again deposited on the ES.

3. Stabilize slopes (Areas 3a [Dam], 3b [Northern Cut Slopes], and 3c [ES Region]).
4. Clean accumulated sediment from the ES.

It is suggested that the repair of the northern cut slope be repaired in accordance with the City's EMR/EMP program. The rationale for this is provided on Sheet 12c.

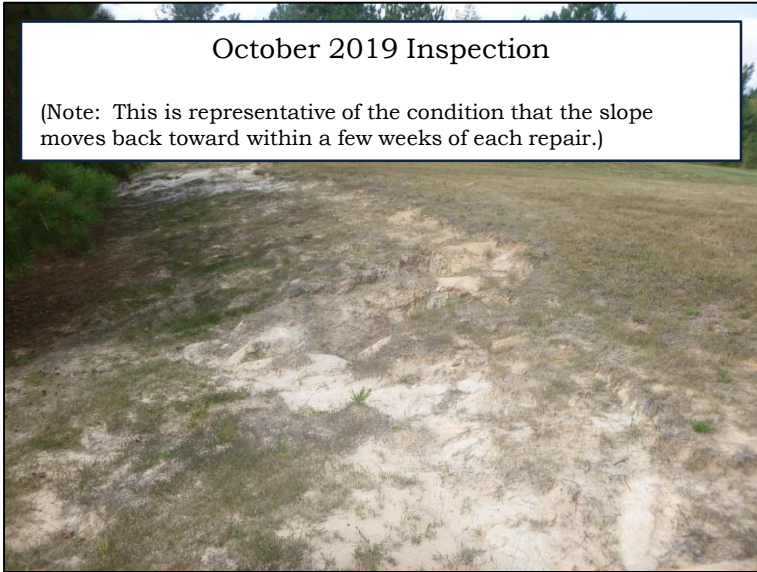
October 2019 Inspection

(Note: This is representative of the condition that the slope moves back toward within a few weeks of each repair.)

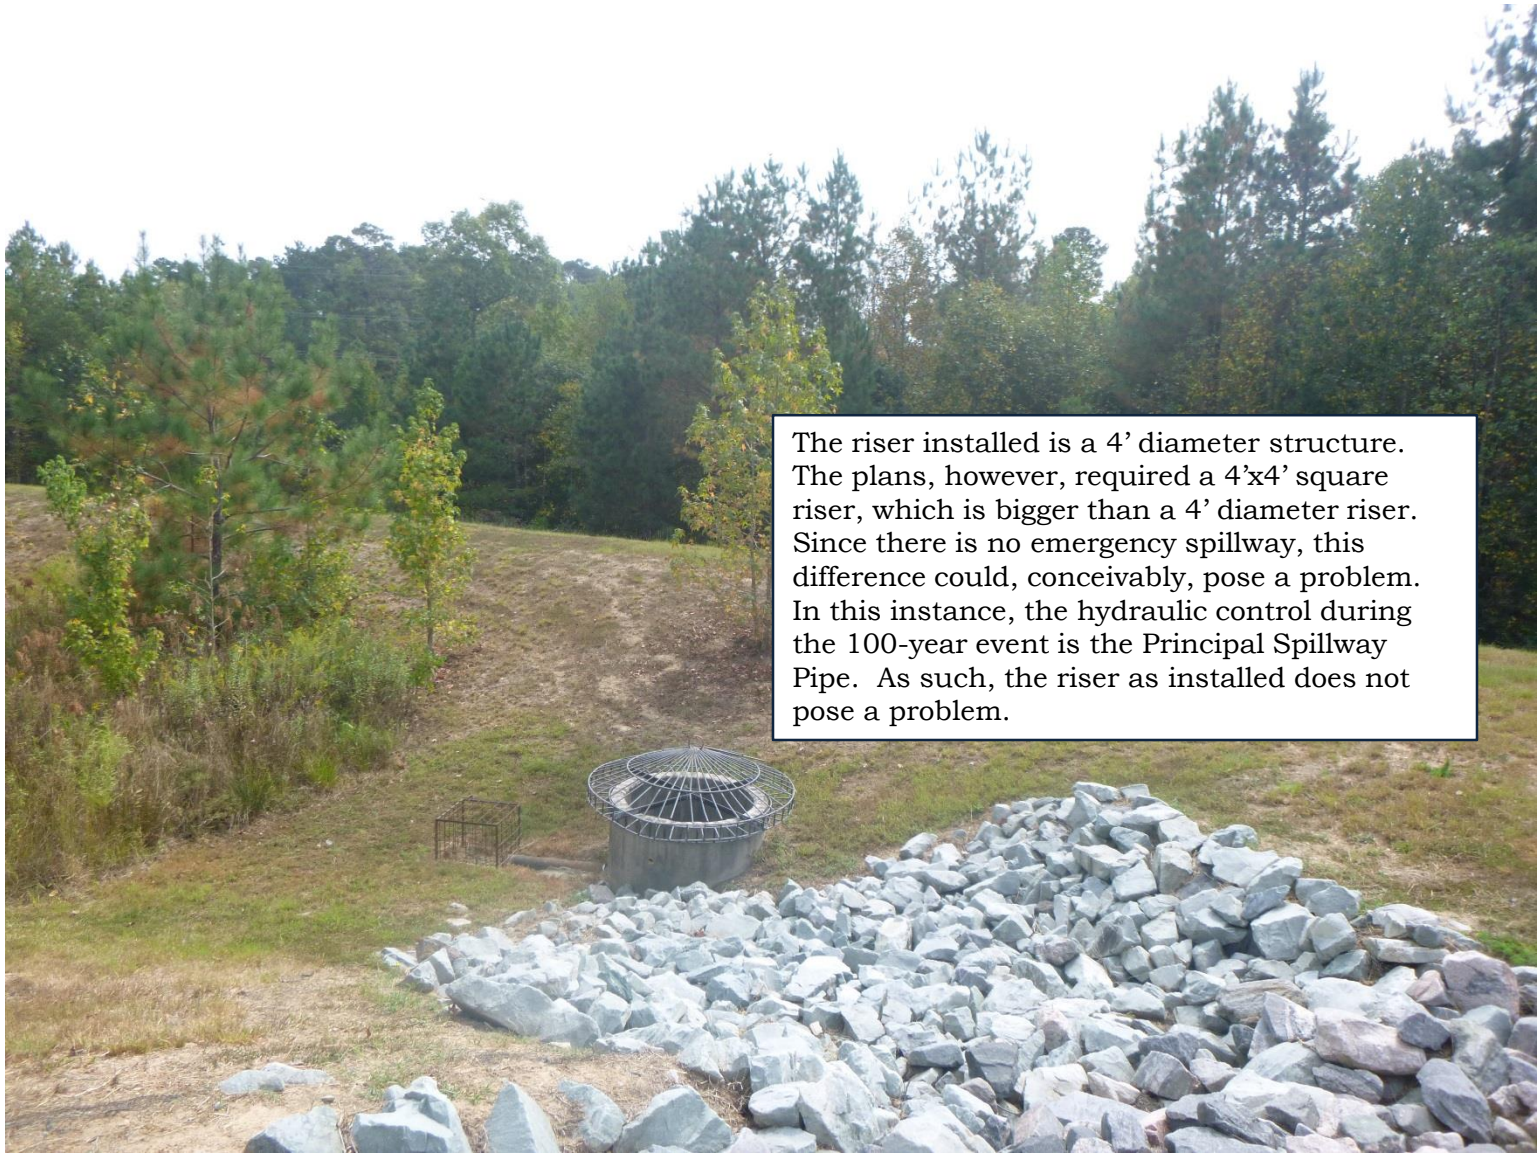
The riser installed is a 4' diameter structure. The plans, however, required a 4'x4' square riser, which is bigger than a 4' diameter riser. Since there is no emergency spillway, this difference could, conceivably, pose a problem. In this instance, the hydraulic control during the 100-year event is the Principal Spillway Pipe. As such, the riser as installed does not pose a problem.

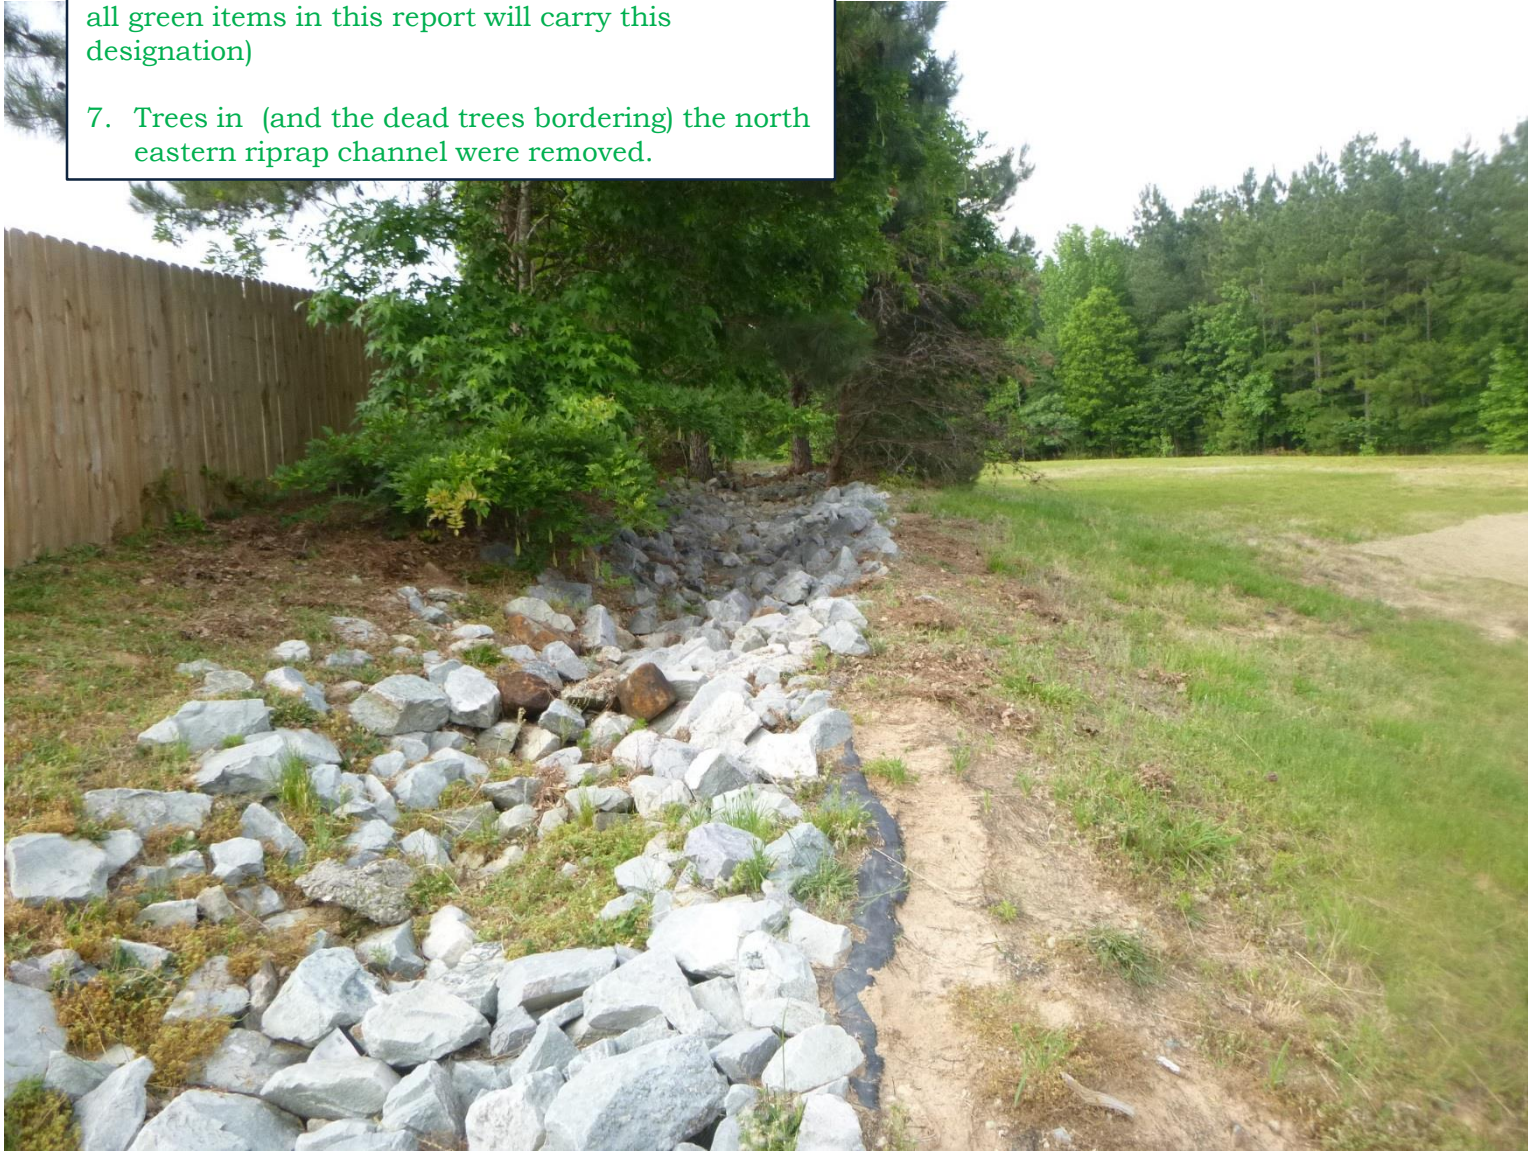
7. Trees in (and the dead trees bordering) the north eastern riprap channel were removed.

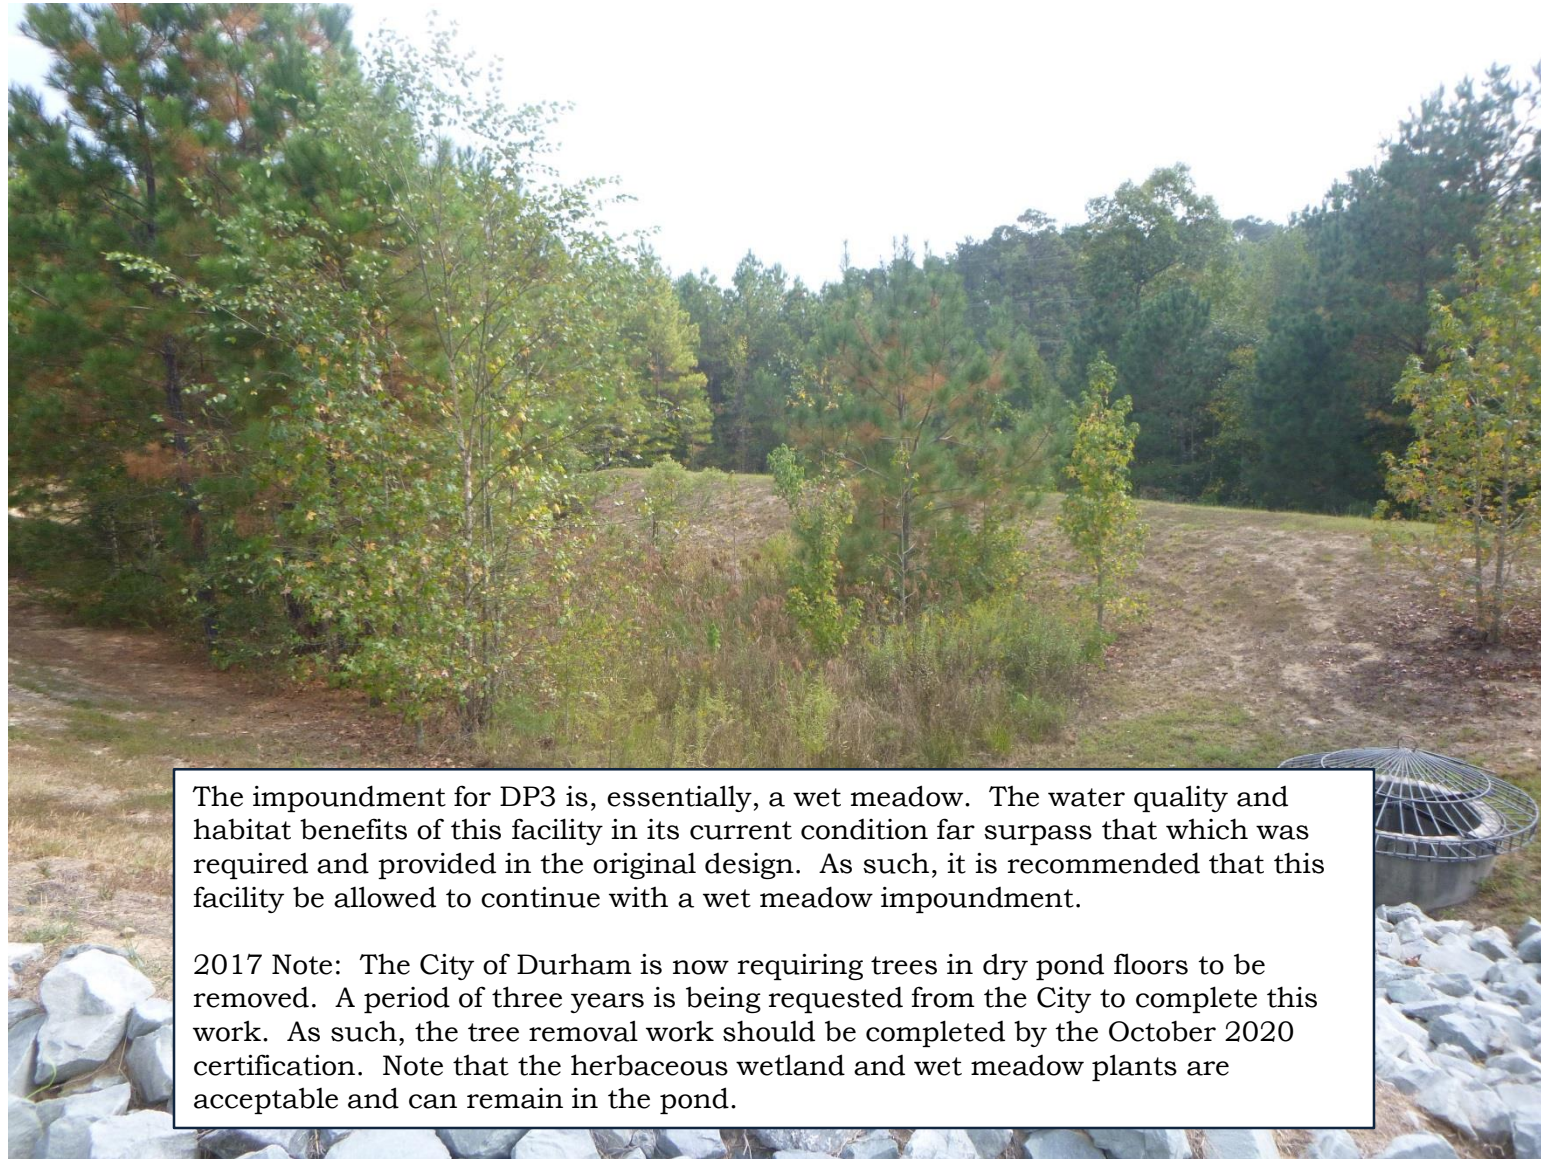
The impoundment for DP3 is, essentially, a wet meadow. The water quality and habitat benefits of this facility in its current condition far surpass that which was required and provided in the original design. As such, it is recommended that this facility be allowed to continue with a wet meadow impoundment.

2017 Note: The City of Durham is now requiring trees in dry pond floors to be removed. A period of three years is being requested from the City to complete this work. As such, the tree removal work should be completed by the October 2020 certification. Note that the herbaceous wetland and wet meadow plants are acceptable and can remain in the pond.

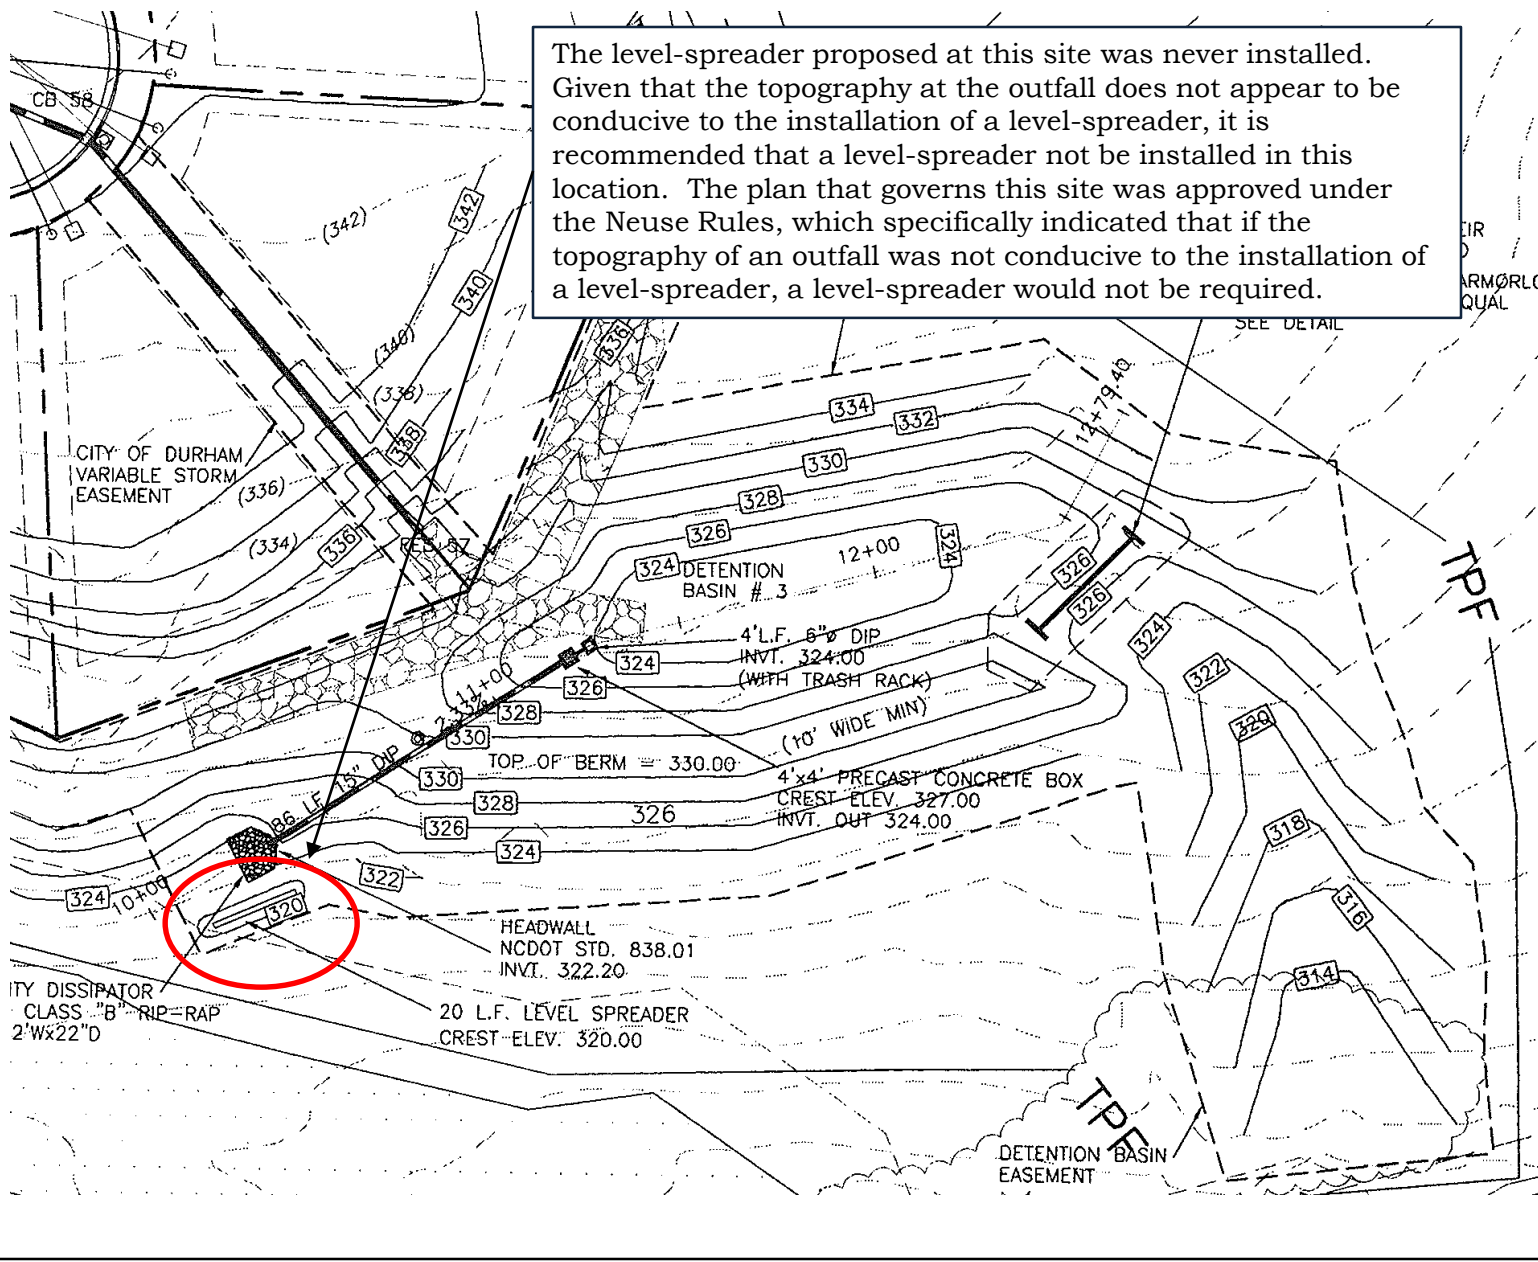
The level-spreader proposed at this site was never installed. Given that the topography at the outfall does not appear to be conducive to the installation of a level-spreader, it is recommended that a level-spreader not be installed in this location. The plan that governs this site was approved under the Neuse Rules, which specifically indicated that if the topography of an outfall was not conducive to the installation of a level-spreader, a level-spreader would not be required.
