# Dry Extended Detention Basin Checklist for Annual SCM Maintenance Certification

<b>Facility ID:</b> <input style="width: 90%;" type="text" value="00410"/>	<b>Date</b> <input style="width: 90%;" type="text" value="Jan 9, 2026"/>
<b>SCM Site/Project Name:</b> <input style="width: 95%;" type="text" value="Glennstone Ph3 DP3"/>

# Glennstone Phase 3 Dry Pond 3

## Annual Inspection Narrative (2025 ACIN)

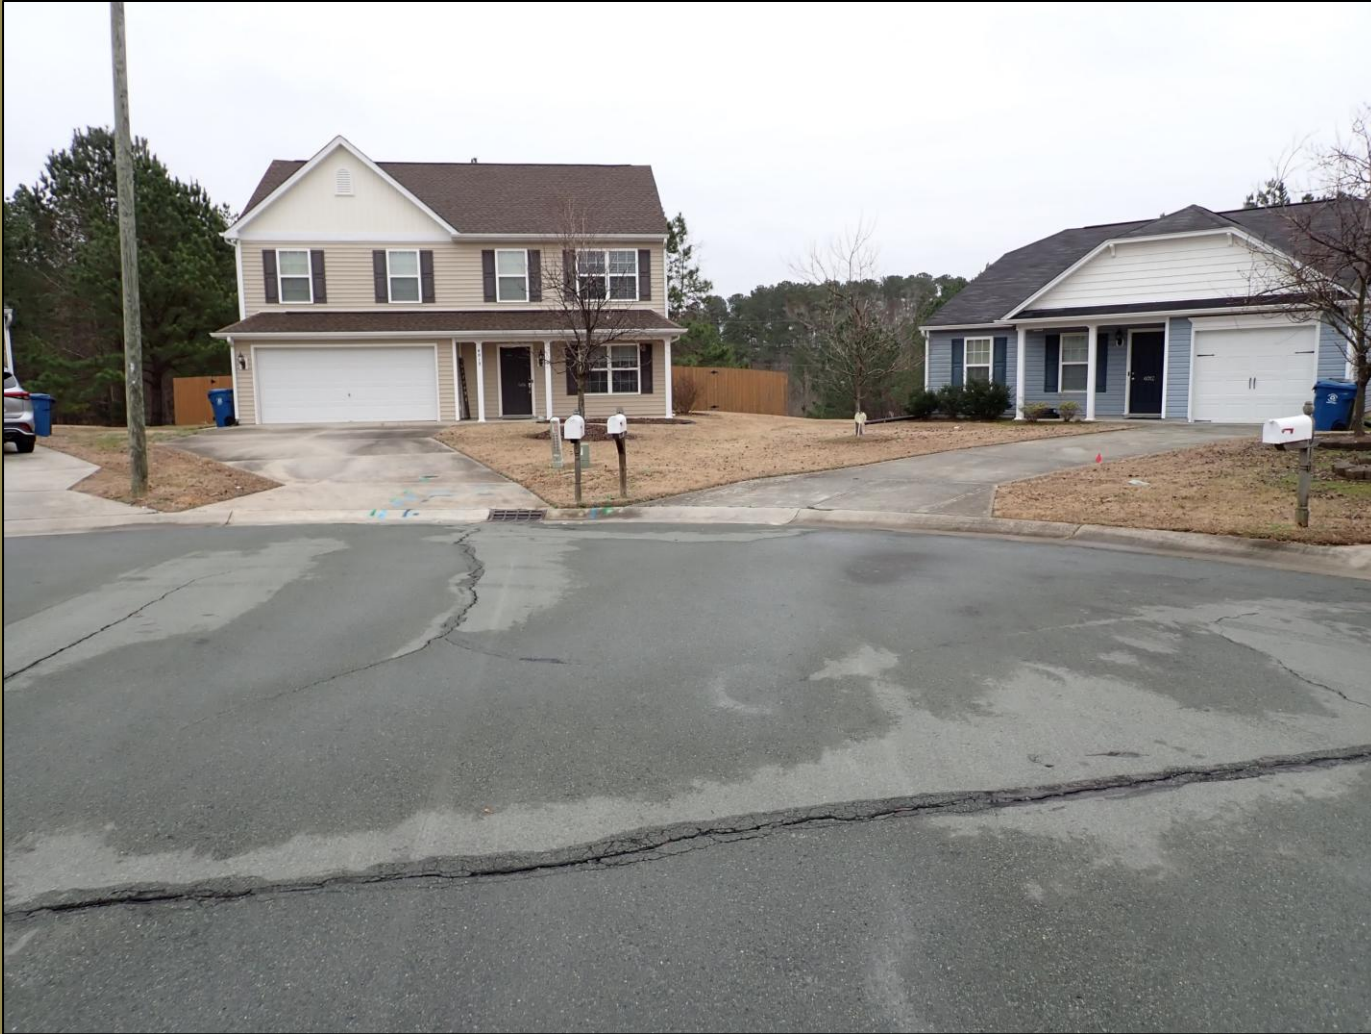
2025-02-06 Annual Certification Inspection

**MFI:** Repair eroded area over inlet (in access). This is in what used to be an overgrown area where the adjacent h/o dumped their grass clippings.

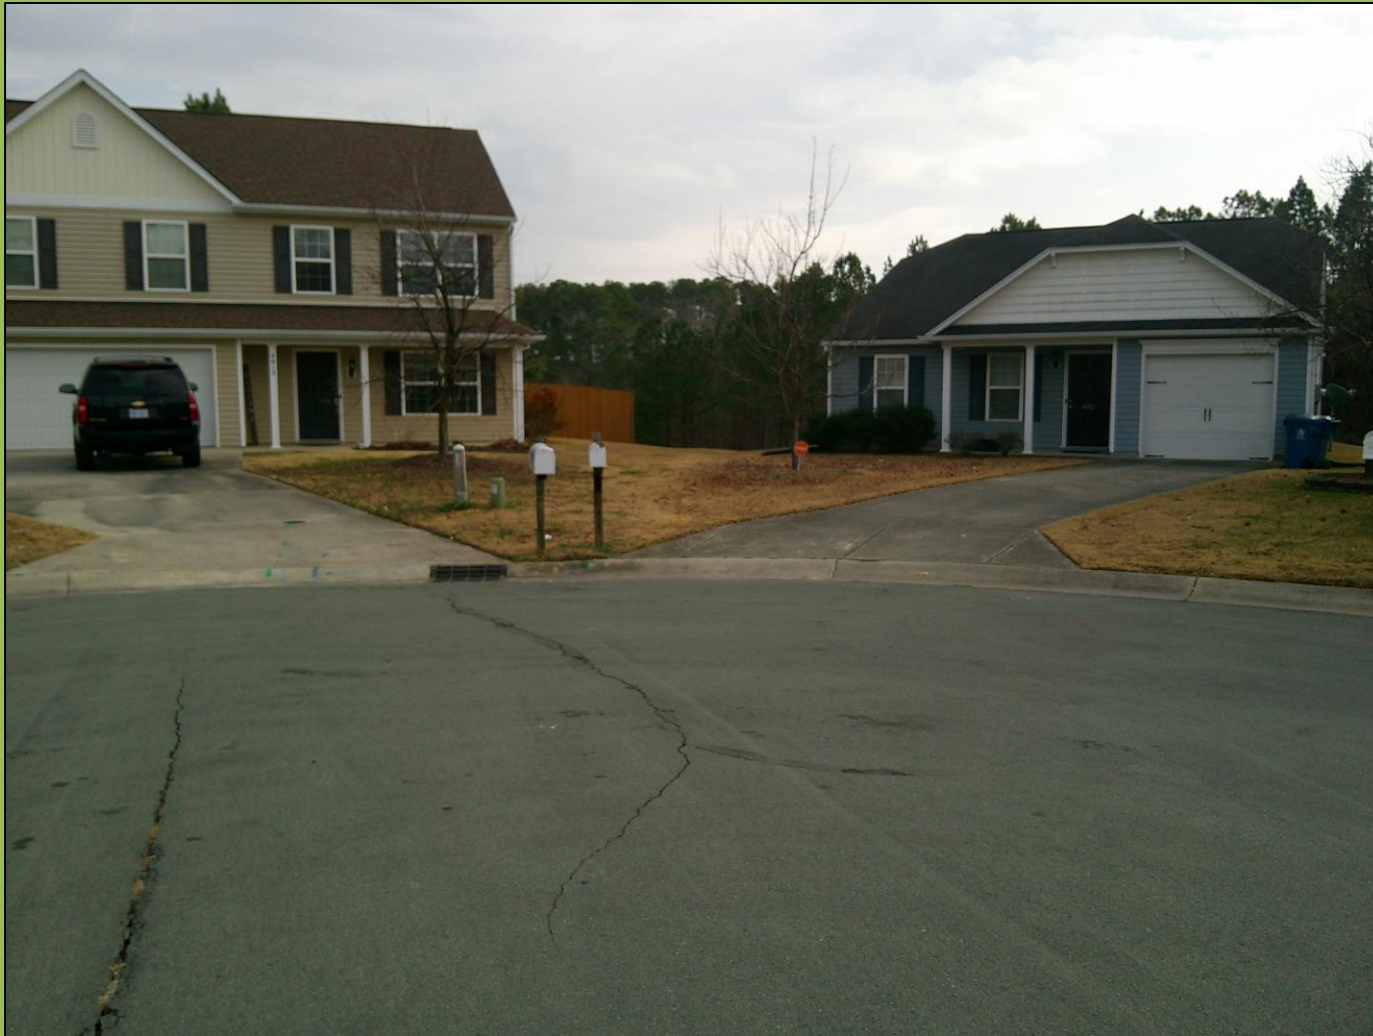
2026-01-09 **Annual Certification** Inspection

**Comment:** The erosion over the inlet pipe, which was caused by the grass-clippings, was repaired in December 2025. In addition, the open joint between the last section of pipe and the flared end-section was diapered with concrete on the outside of the pipe. IN addition, the inside of the joint was parged with grout.

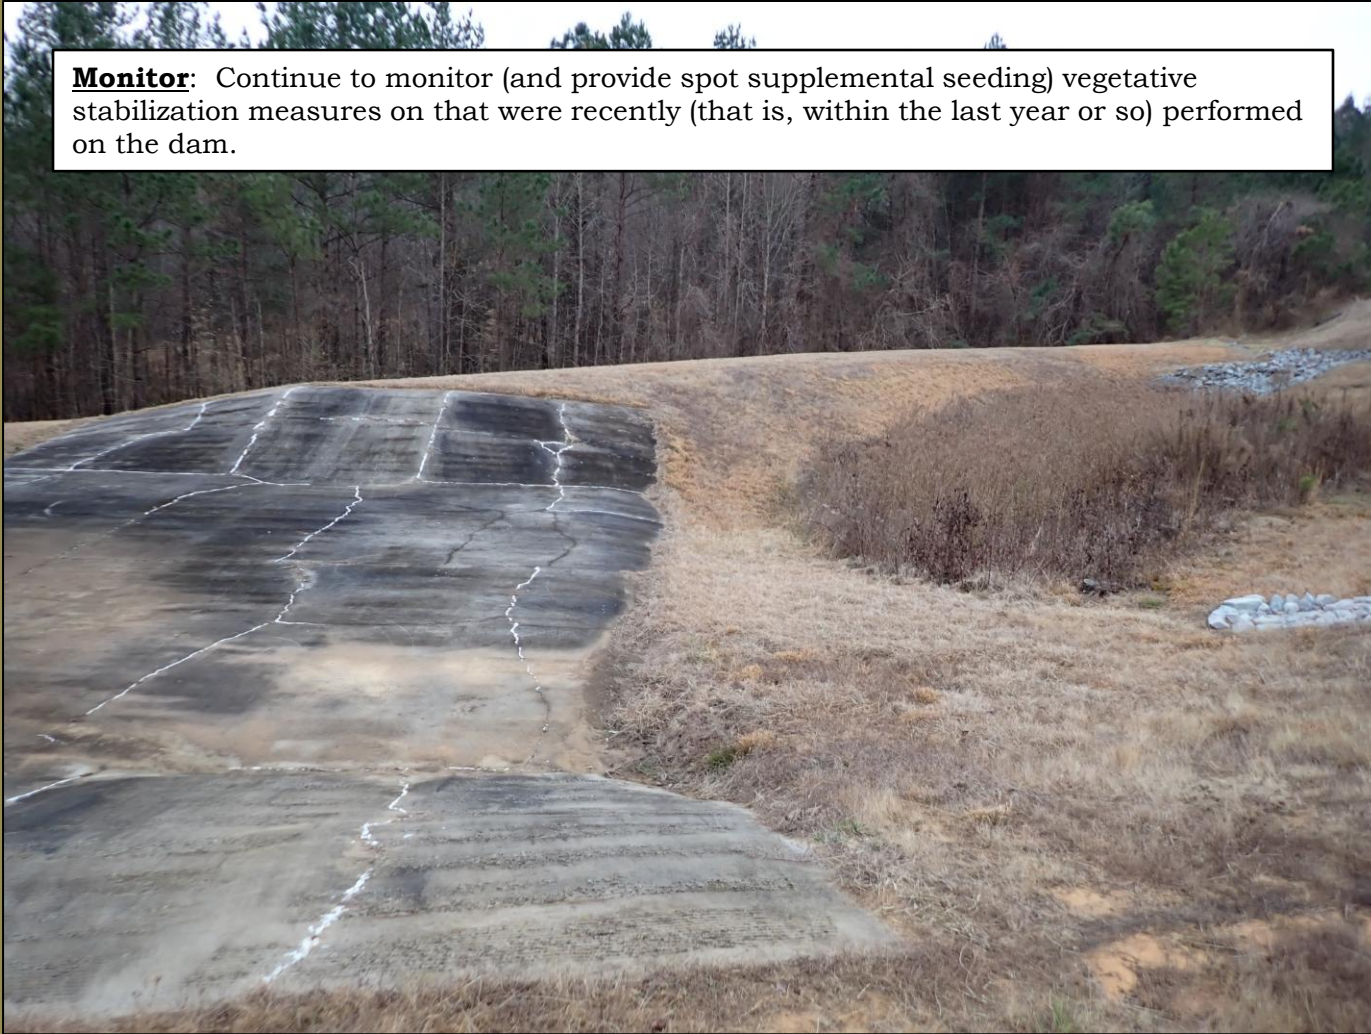
**Monitor:** Continue to monitor (and provide spot supplemental seeding) vegetative stabilization measures on that were recently (that is, within the last year or so) performed on the dam.

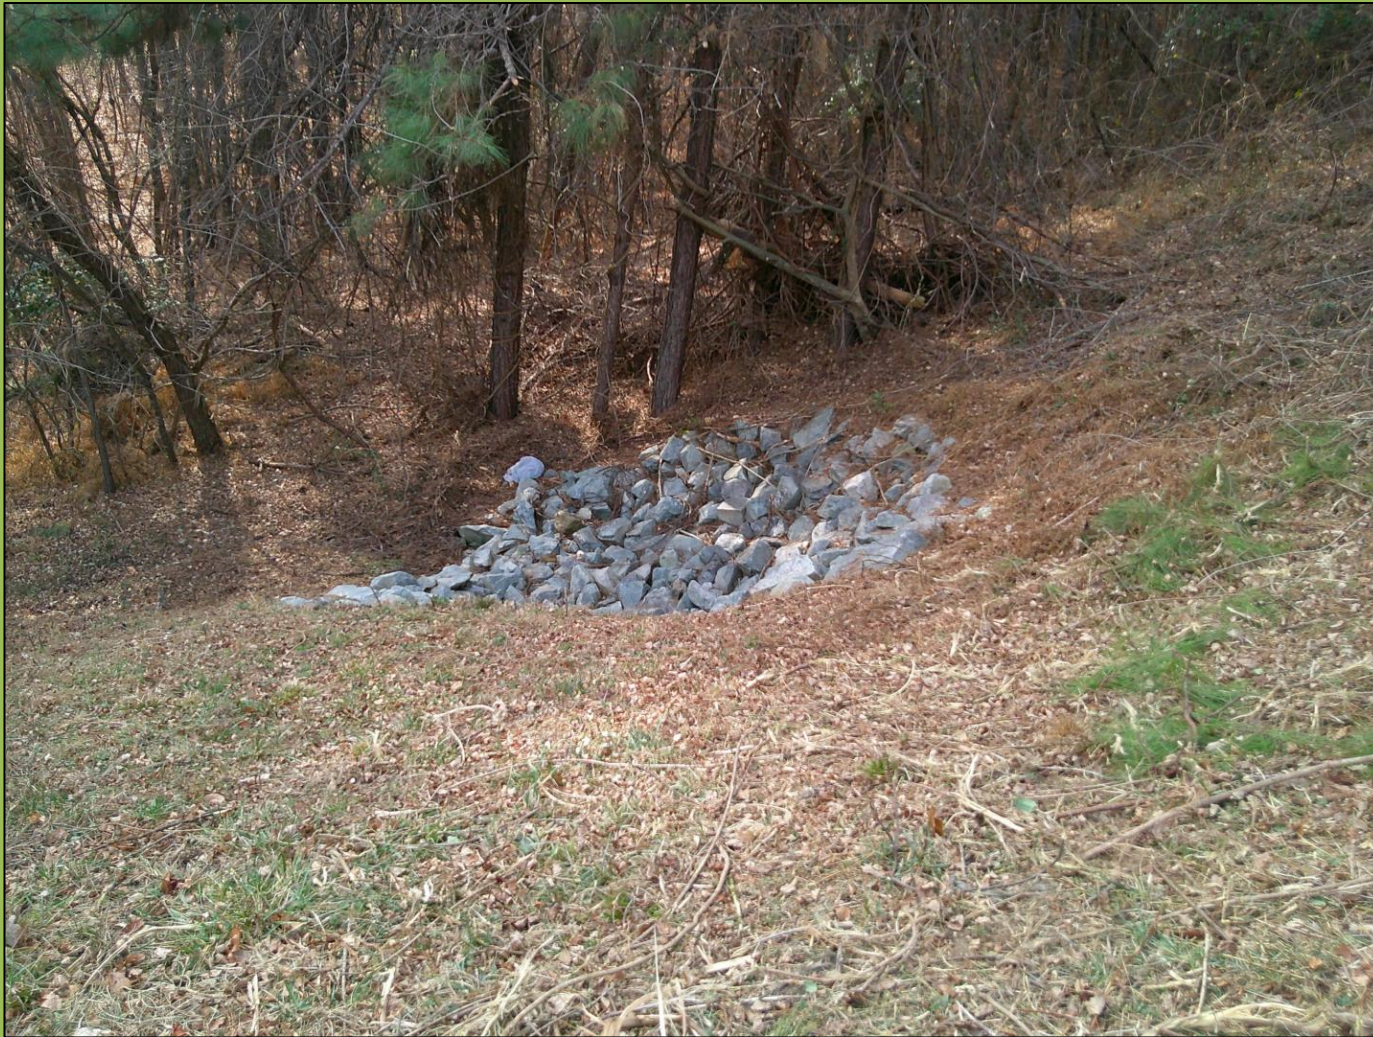
2026-01-09 **Annual Certification** Inspection

**MFI:** Repair erosion and stabilize area on slope adjacent to ES entry channel. Once this work is complete, clean the sediment of the concrete portion of the ES.

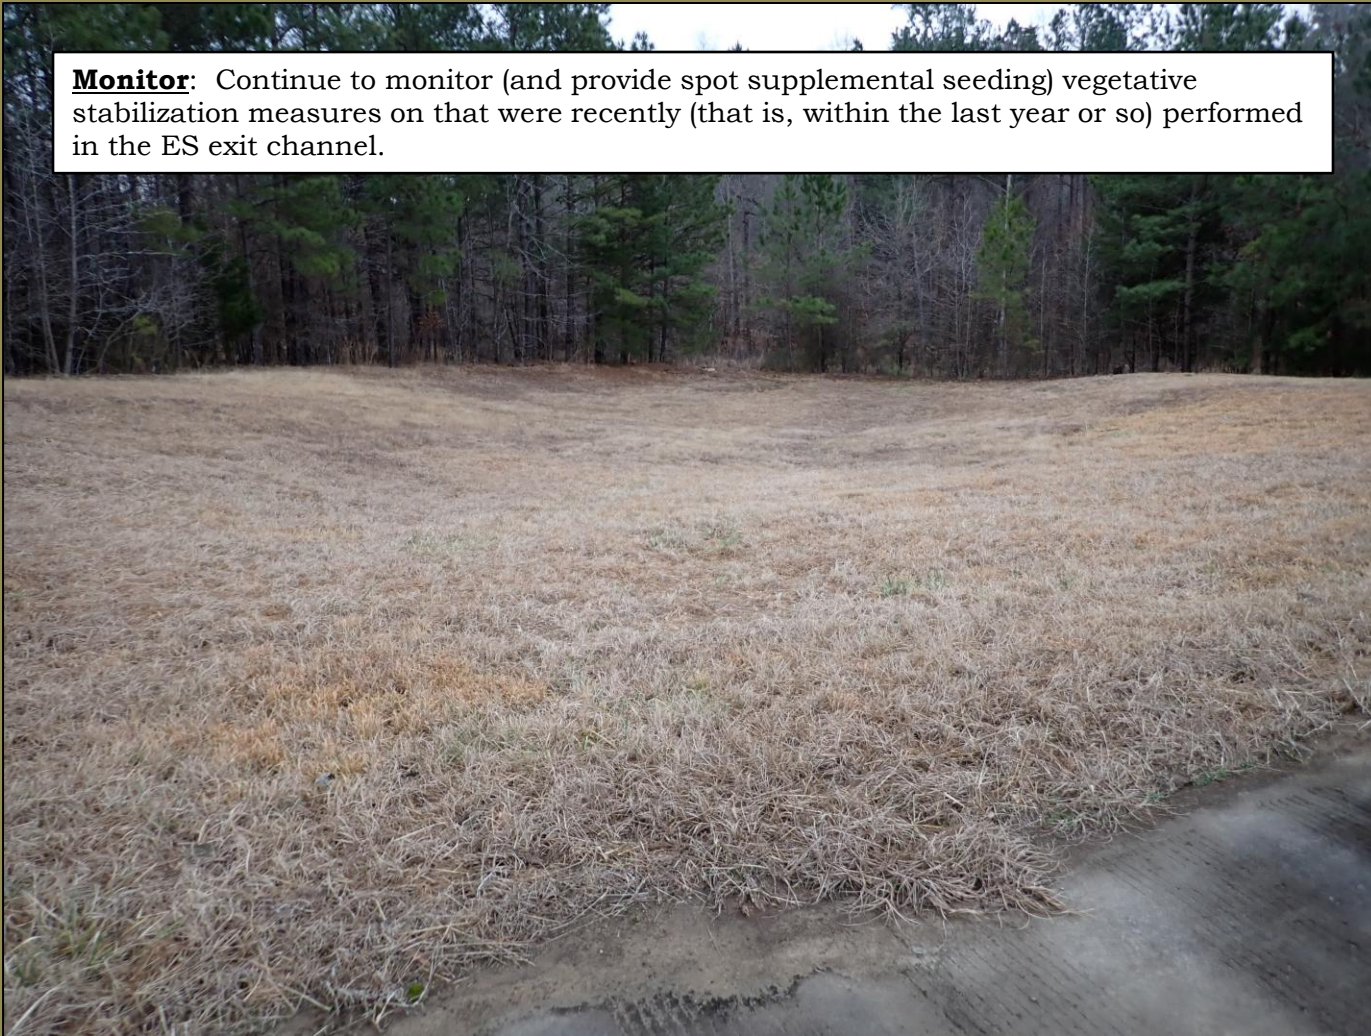
**Monitor:** Continue to monitor (and provide spot supplemental seeding) vegetative stabilization measures on that were recently (that is, within the last year or so) performed in the ES exit channel.

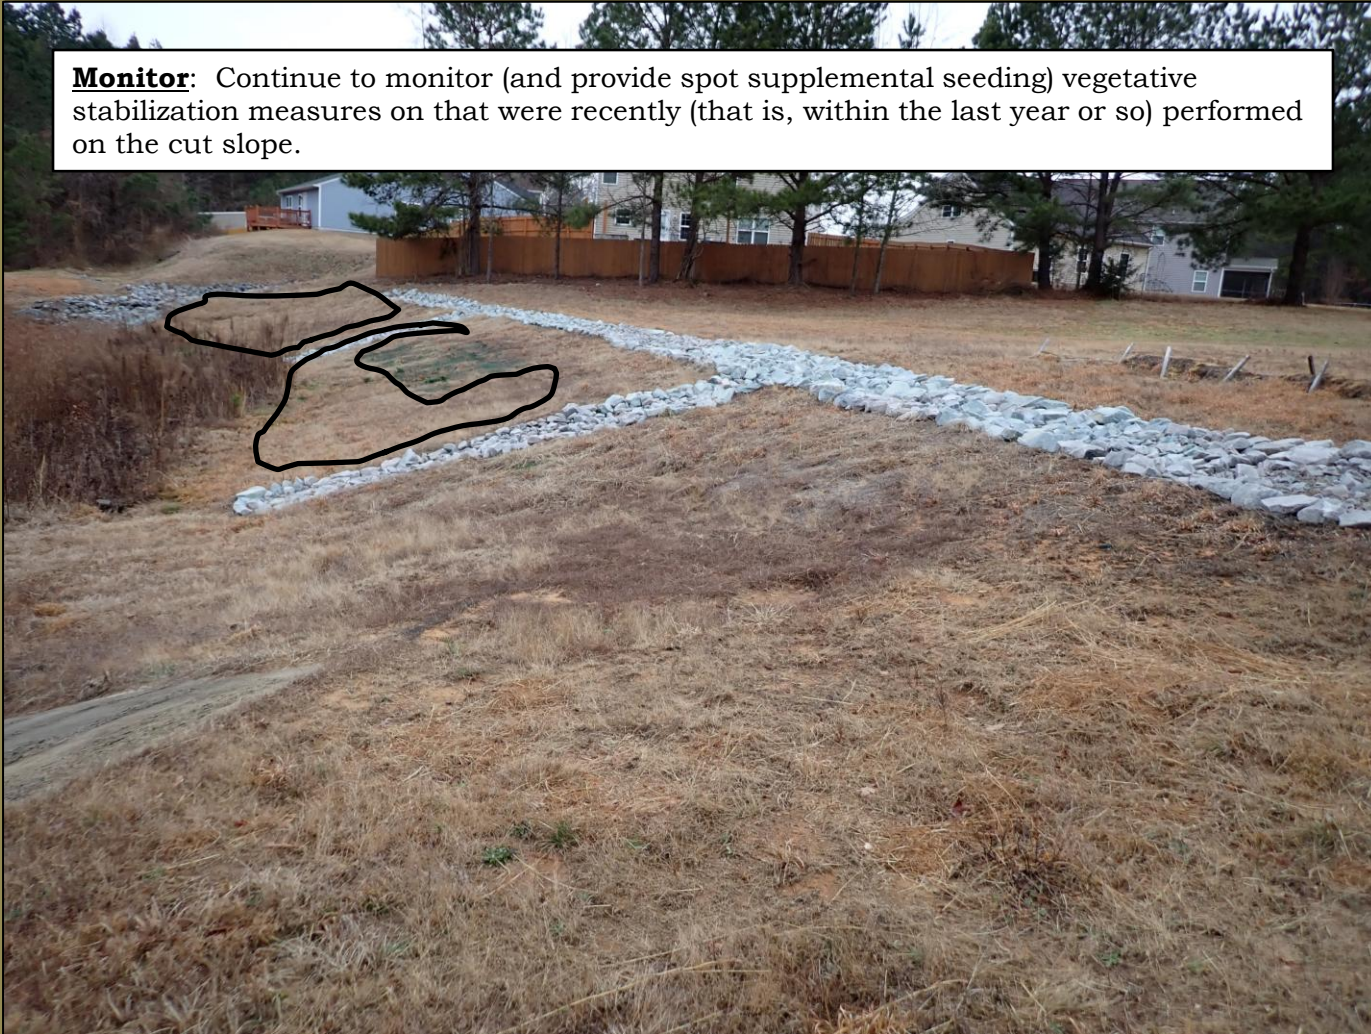
**Monitor:** Continue to monitor (and provide spot supplemental seeding) vegetative stabilization measures on that were recently (that is, within the last year or so) performed on the cut slope.

Typically, any bare areas should be raked, amended, seeded, and mulched. The best times to complete such work are in the early fall and early spring. The back cut slope is comprised largely of sand stone, which is highly erodible and has been difficult to stabilize. In lieu of trying to stabilize this area with vegetation, it is recommended that any sediment deposited in the pond from this slope be removed as needed.

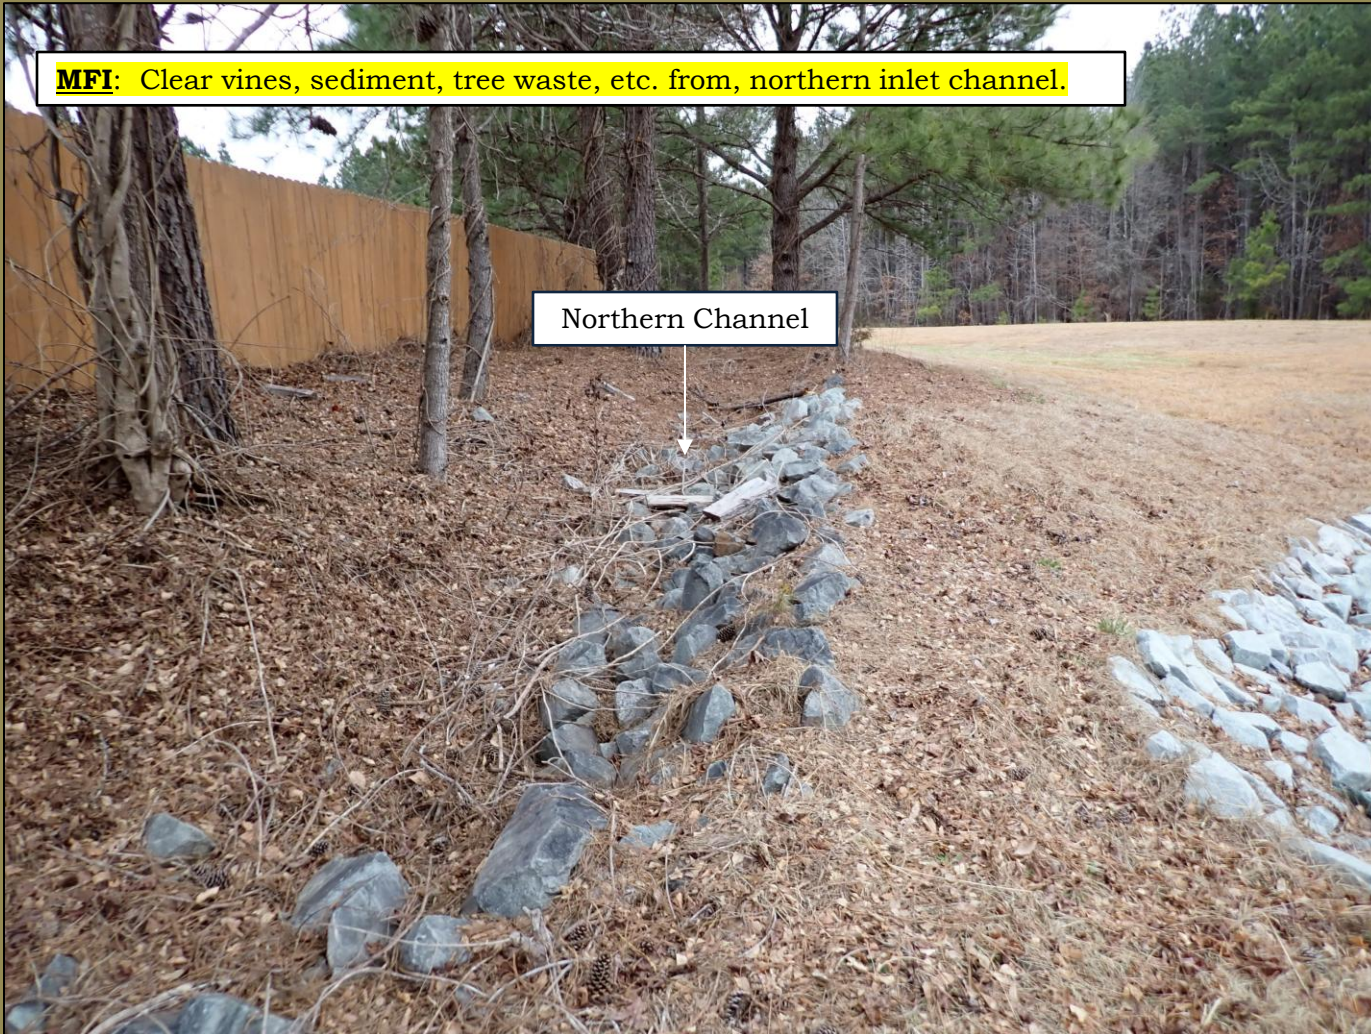
Northern Channel

**MFI:** Clear vines, sediment, tree waste, etc. from, northern inlet channel.

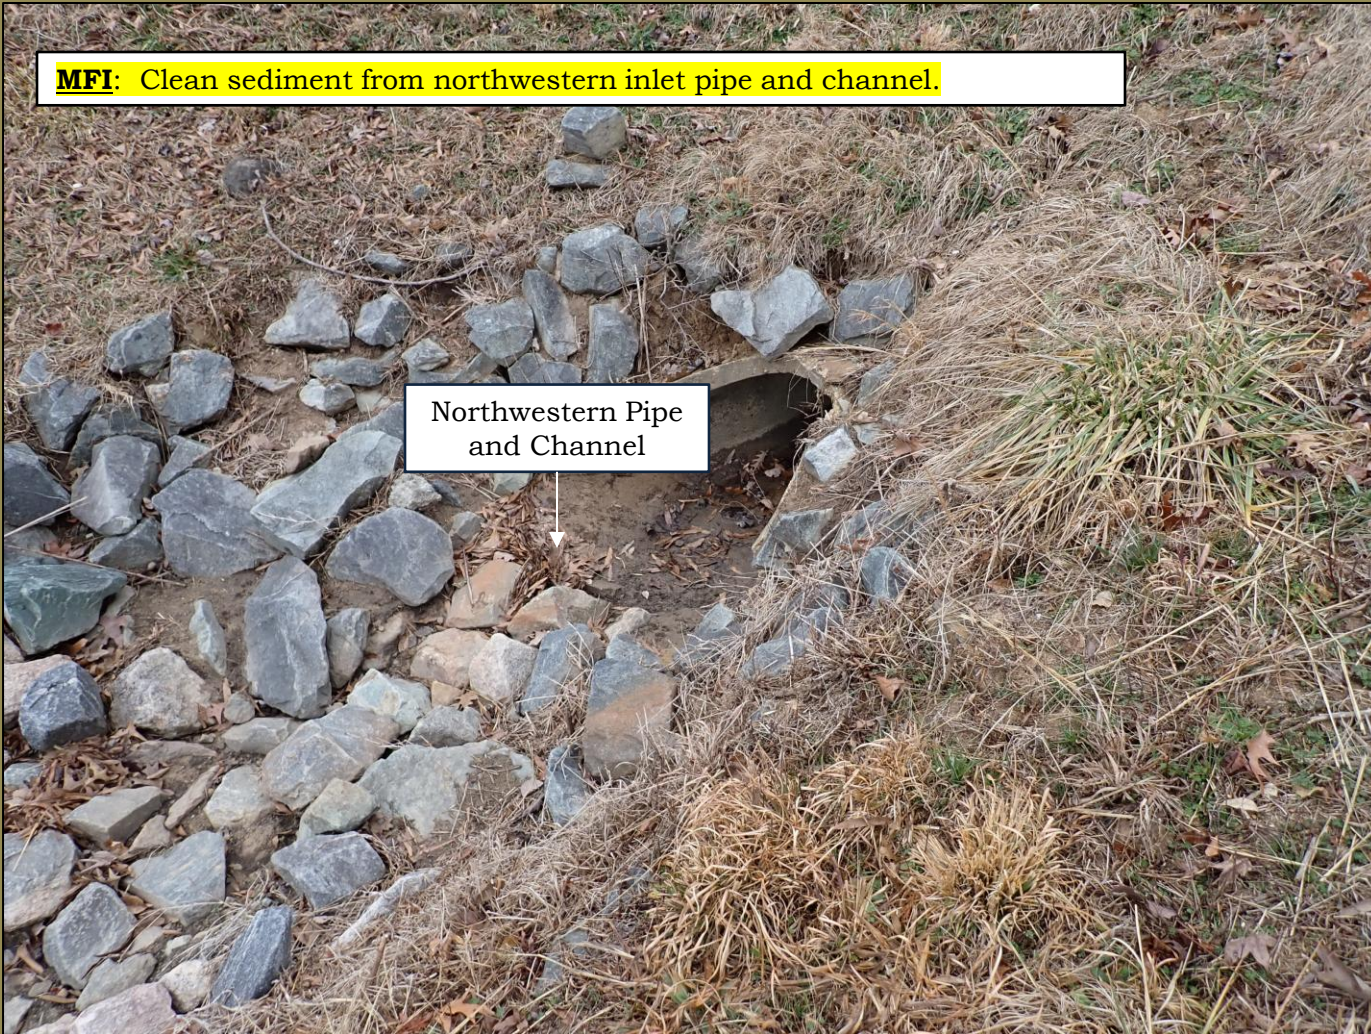
Northwestern Pipe  
and Channel

**MFI:** Clean sediment from northwestern inlet pipe and channel.

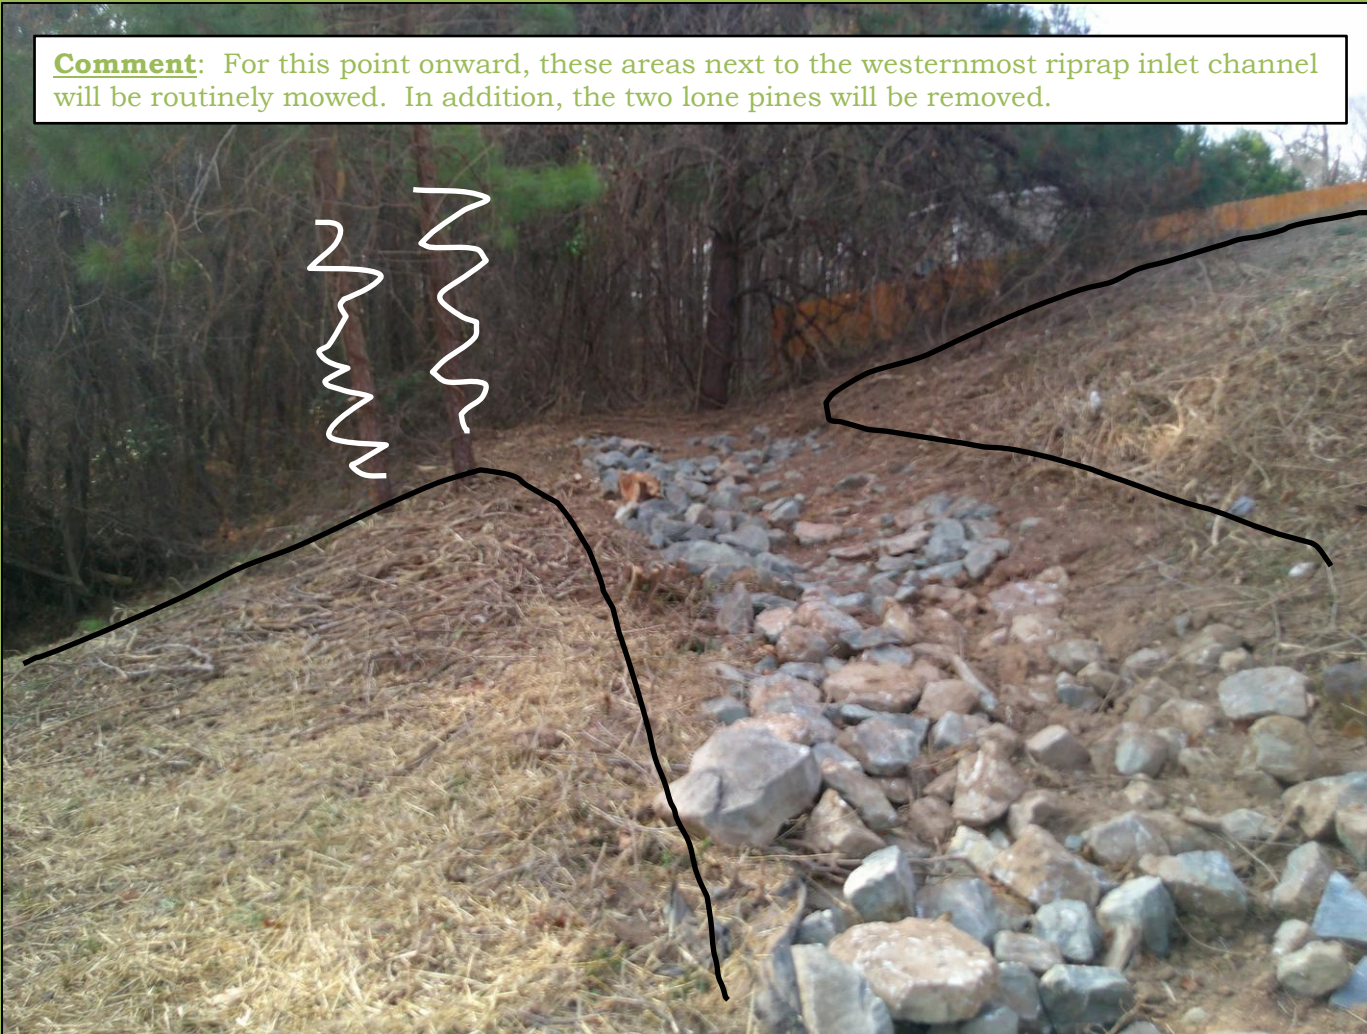
**Comment:** For this point onward, these areas next to the westernmost riprap inlet channel will be routinely mowed. In addition, the two lone pines will be removed.

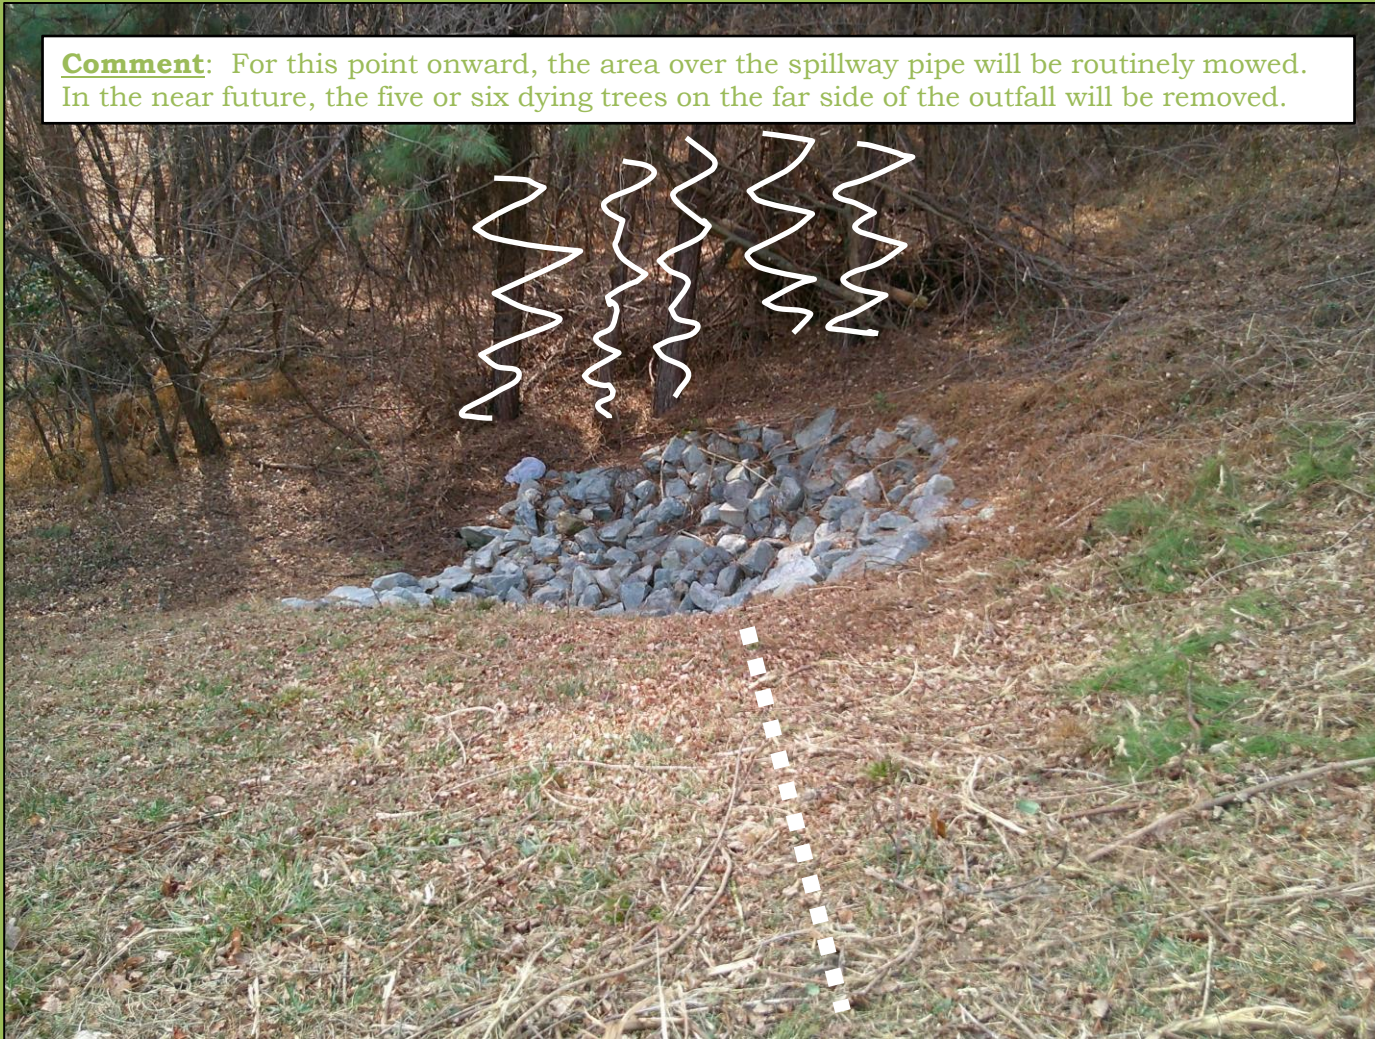
**Comment:** For this point onward, the area over the spillway pipe will be routinely mowed. In the near future, the five or six dying trees on the far side of the outfall will be removed.

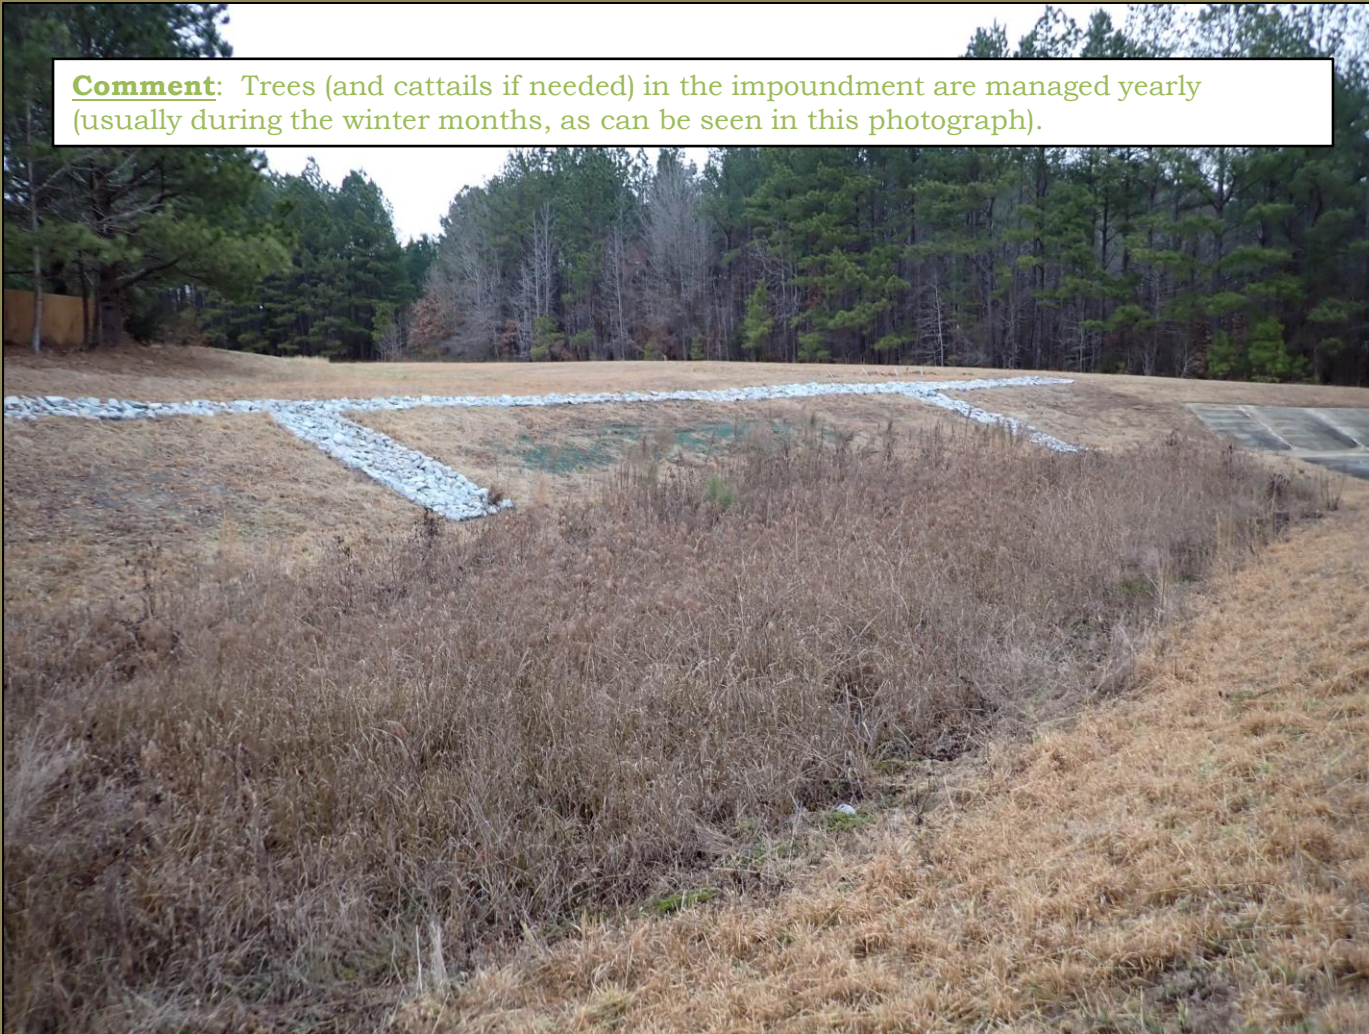
**Comment:** Trees (and cattails if needed) in the impoundment are managed yearly (usually during the winter months, as can be seen in this photograph).
