Glennstone Phase 3 Dry Pond 3

(City of Durham ID# 00410)

Annual Certification Inspection Journal (ACIJ) – Interim Report

July 2020

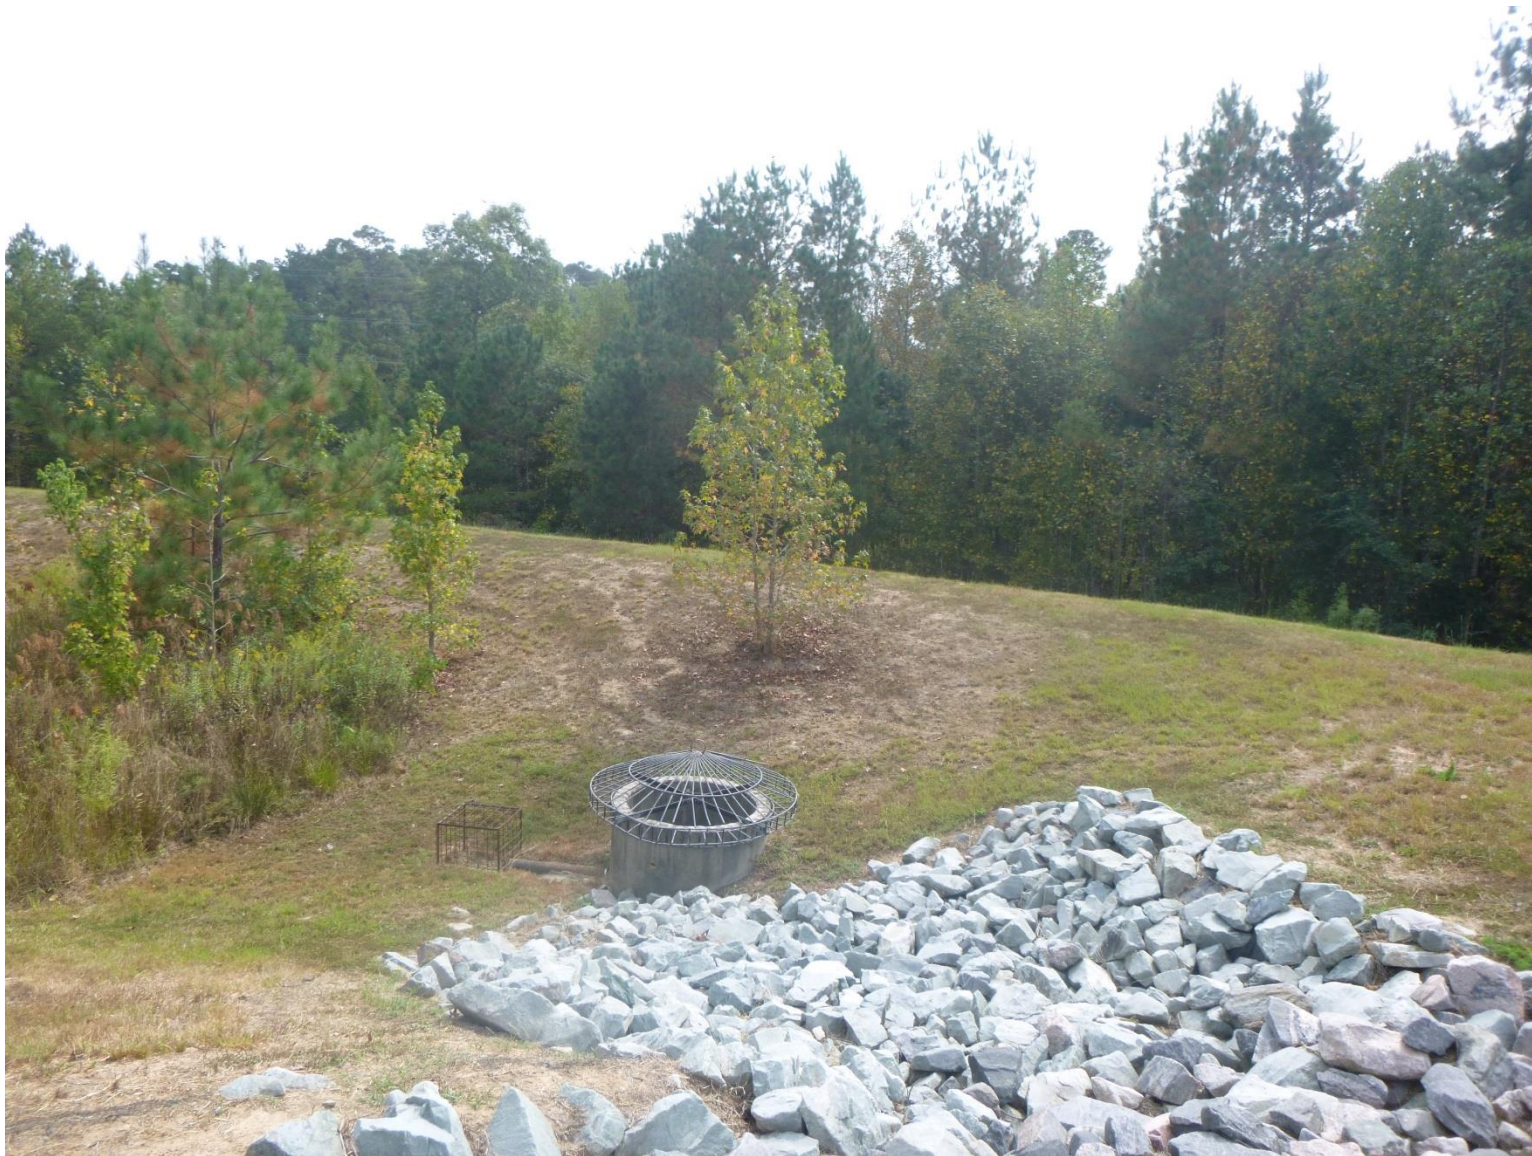
October 2019 Inspection

1. The small tree on the dam was removed.
2. All trees in the impoundment were removed.
3. Attempts were made to stabilize the unstable slopes, but the repairs (in large part) did not take.

Work Item's to be Competed Prior to 2020 Certification (Note: Henceforth, all red items in this report will carry this designation.):

3. Stabilize slopes (Areas 3a [Dam], 3b [Northern Cut Slopes], and 3c [ES Region]).

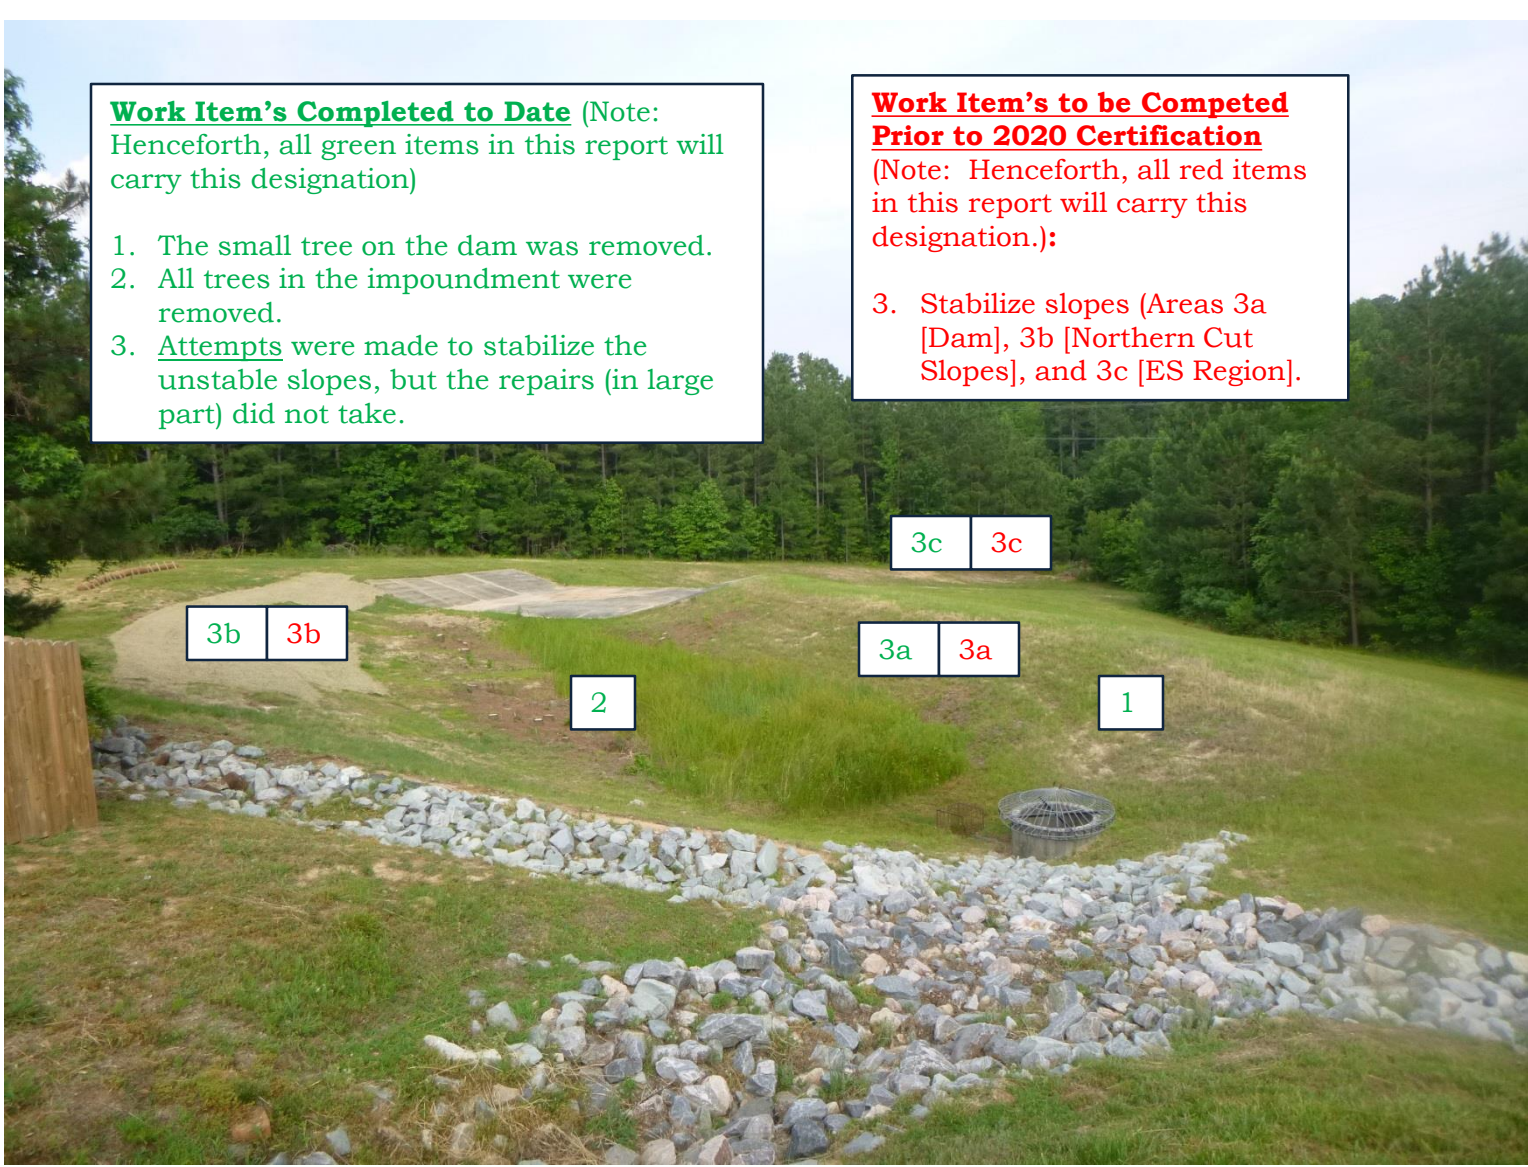
June 2020

1. The small tree on the dam was removed.
2. All trees in the impoundment were removed.
3. Attempts were made to stabilize the unstable slopes, but the repairs (in large part) did not take.

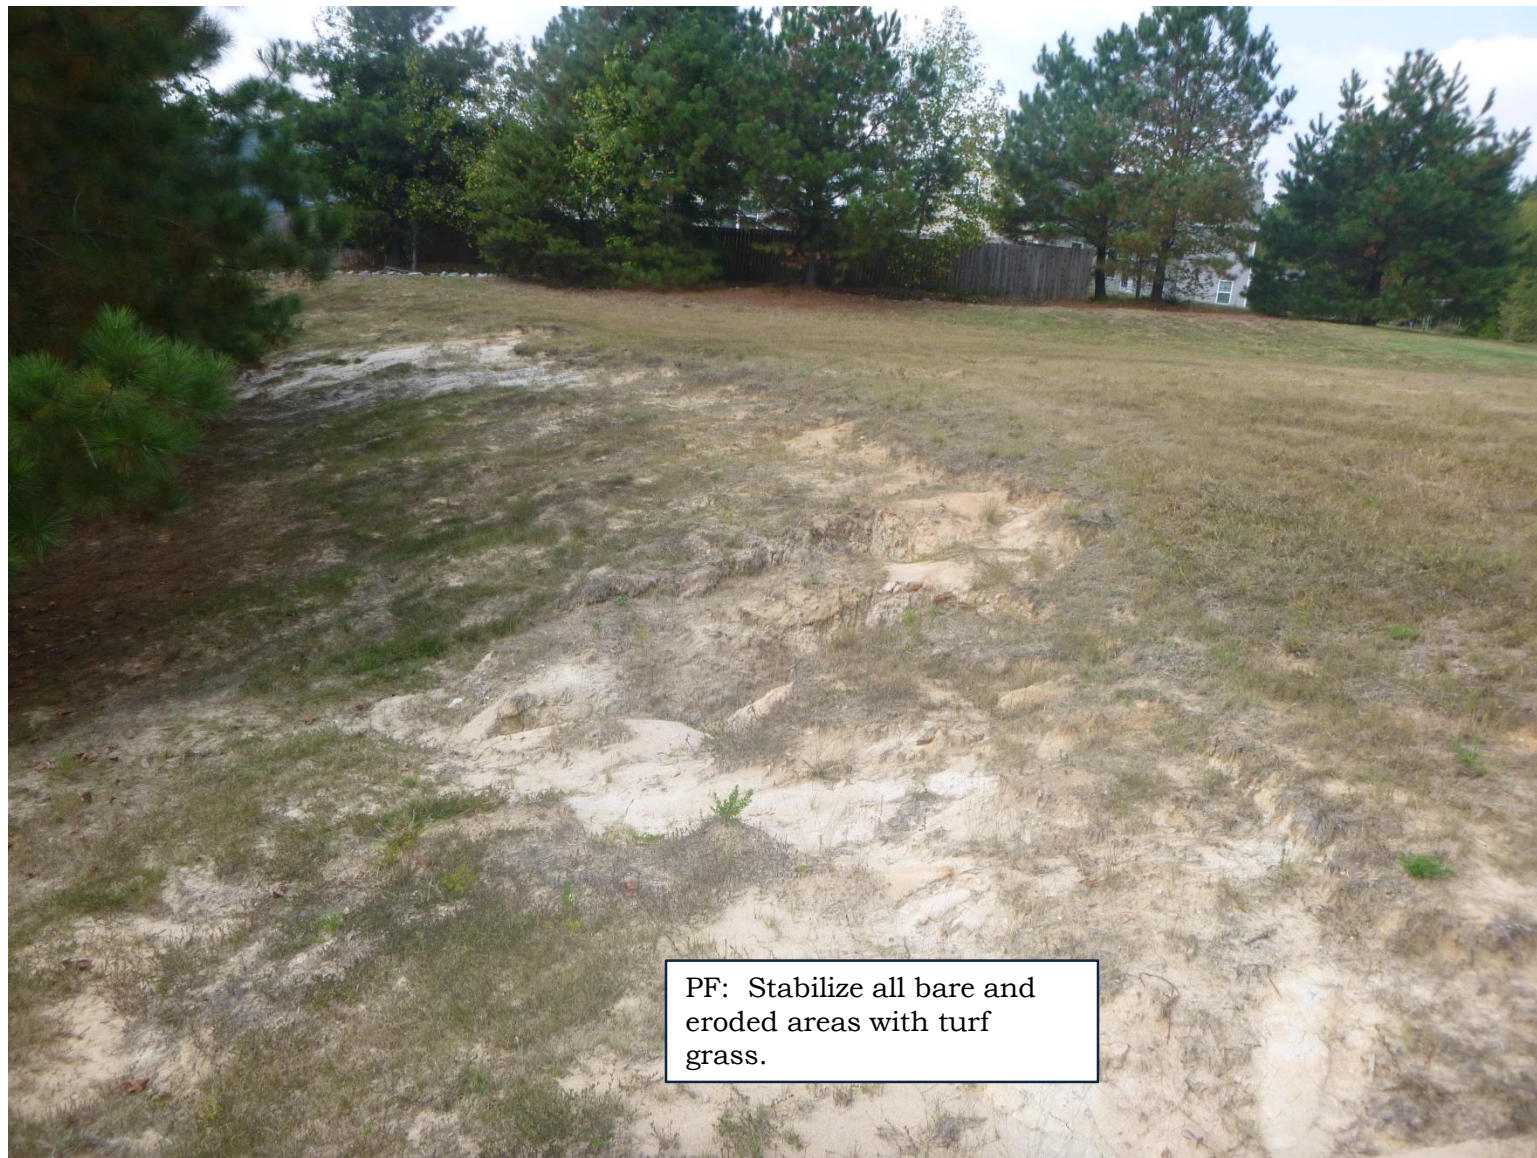
October 2019 Inspection

2. All trees in the impoundment were removed.
3. Attempts were made to stabilize the unstable slopes, but the repairs (in large part) did not take.
4. Sediment deposited on the ES was cleaned, and the cracks were sealed. However, due to continual erosion upstream of the ES, sediment has once again deposited on the ES.

PF: Stabilize all bare and eroded areas with turf grass.

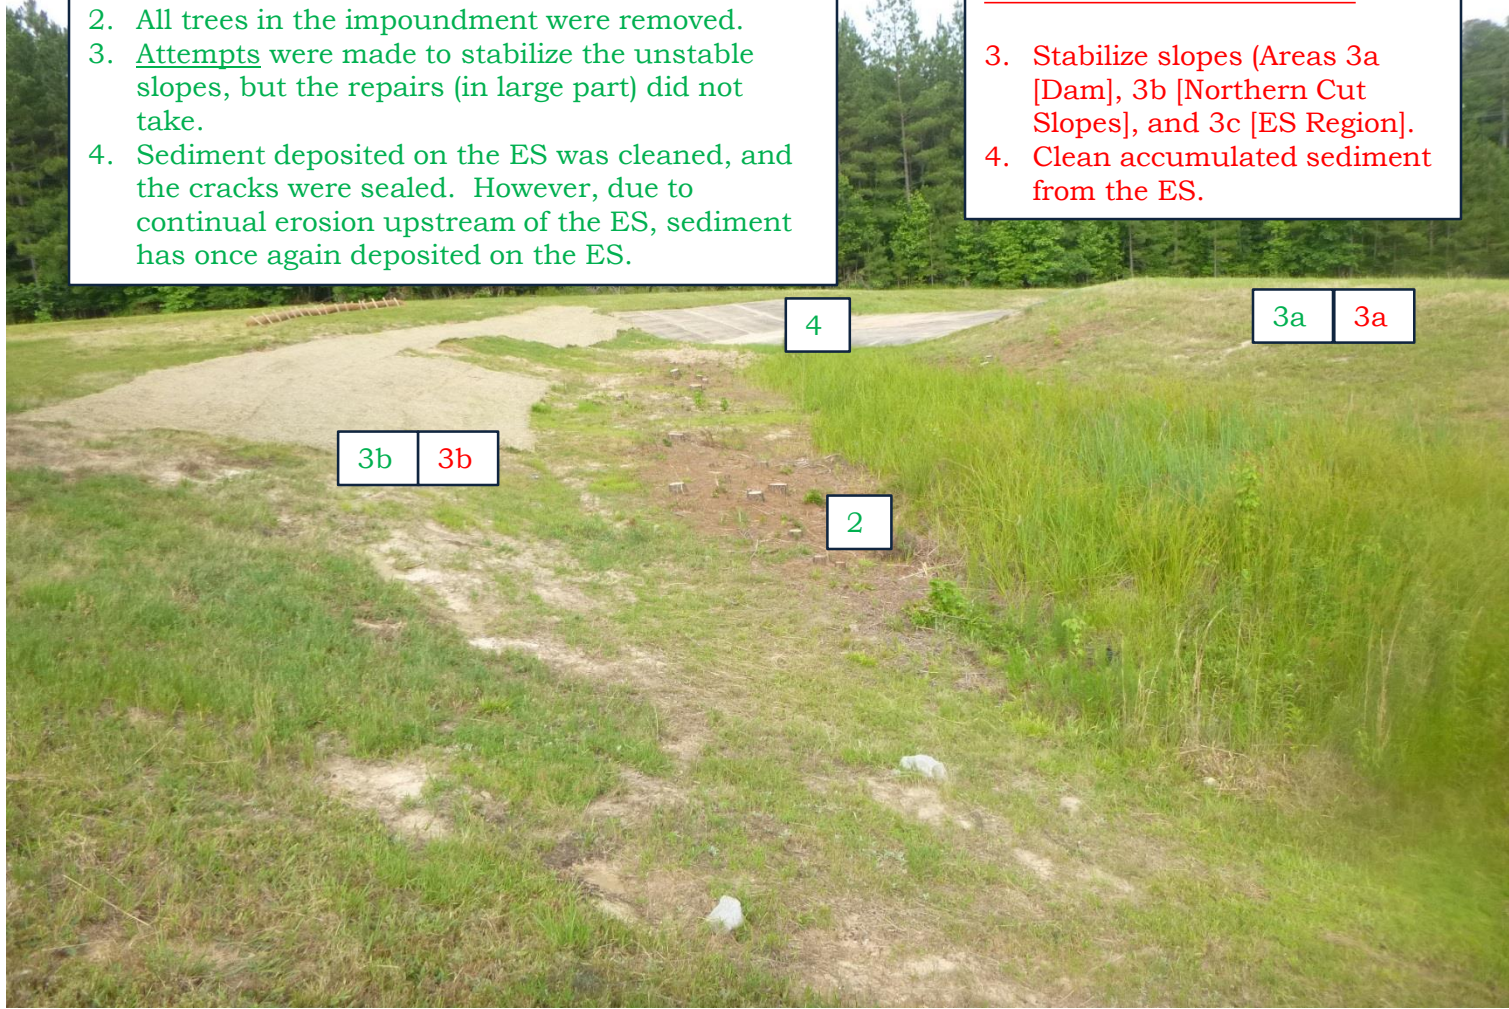
June 2020

2. All trees in the impoundment were removed.
3. Attempts were made to stabilize the unstable slopes, but the repairs (in large part) did not take.
4. Sediment deposited on the ES was cleaned, and the cracks were sealed. However, due to continual erosion upstream of the ES, sediment has once again deposited on the ES.

Work Item's to be Completed Prior to 2020 Certificatio:

3. Stabilize slopes (Areas 3a [Dam], 3b [Northern Cut Slopes], and 3c [ES Region]).
4. Clean accumulated sediment from the ES.
